Renewing Culverts with Ribline

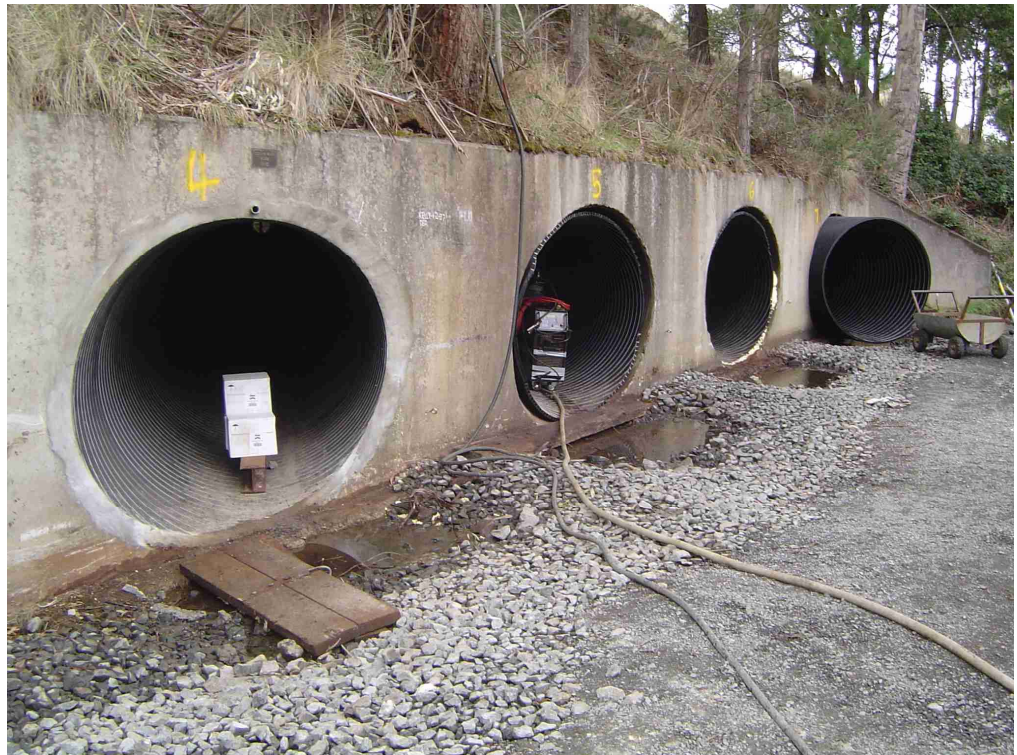
Culverts with liners in various stages of completion. The culvert on the left has been grouted and end sealed and is virtually complete. The centre two culverts have yet to be grouted, while the far culvert has yet to be trimmed.
