CASE STUDY

Port Macquarie-Hastings  
Council

Stormwater Pipe  
Rehabilitation

## LINING TO A SUBMERGED OUTLET

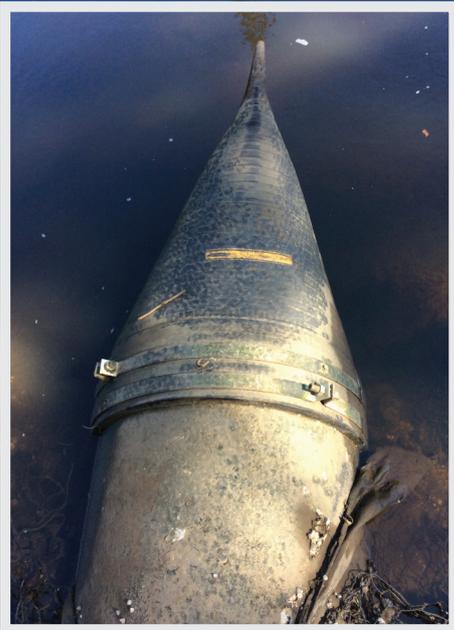
A stormwater pipe draining to a waterway in Port Macquarie had deteriorated, with heavy infiltration through open joints and shellfish encrustation of the pipe walls. The reduction of its flow capacity contributed to regular upstream flooding. Rectification was complicated by the pipe outlet frequently being totally submerged and the pipe diameter varying from DN800 to DN950.

The submerged outlet of the pipe

To avoid disruption in the CBD, Interflow installed the SPR™ EX - Expanda Pipe liner from the downstream end, even though this was submerged much of the time. Work took place from a coffer dam installed at the end of the pipe. Dewatering inside the dam was carried out with Interflow's Super 2000, usually used as a combination recycling jetter.

The liner was installed from the dewatered coffer dam. As SPR™ EX - Expanda Pipe is mechanically expanded during the installation process, it was able to efficiently handle the variations in diameter along the pipe length. Installation does not block the pipe and heating is not part of the process, so work could be undertaken in working hours limited by low tide with the liner partially submerged.

Following the completed lining, a duck bill flap was installed at the pipe outlet to limit backflow into the line.
