PROJECT NAME
Stormwater Rehabilitation

LOCATION
Mooloolaba, QLD

CASE STUDY

ROTALOC LINING TO A SUBMERGED OUTLET

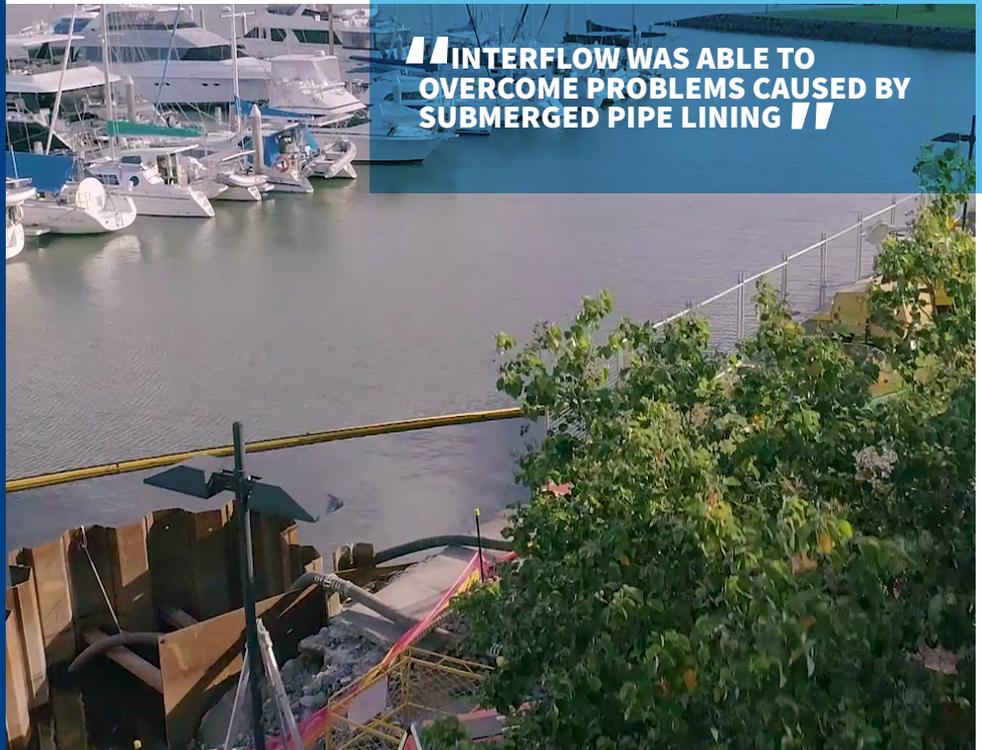
INTERFLOW WAS ABLE TO OVERCOME PROBLEMS CAUSED BY SUBMERGED PIPE LINING

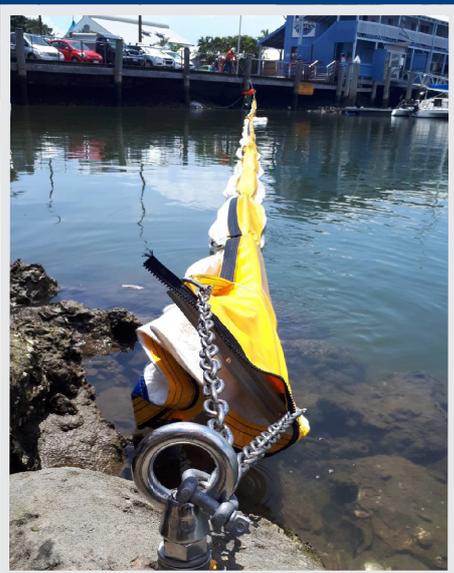
The pipeline outfall in the marina was always at least partially submerged
