NEW CONTRACT STRUCTURE LEADS TO OPTIMUM SEWER REHABILITATION PROGRAM

John Monro Interflow Pty Limited

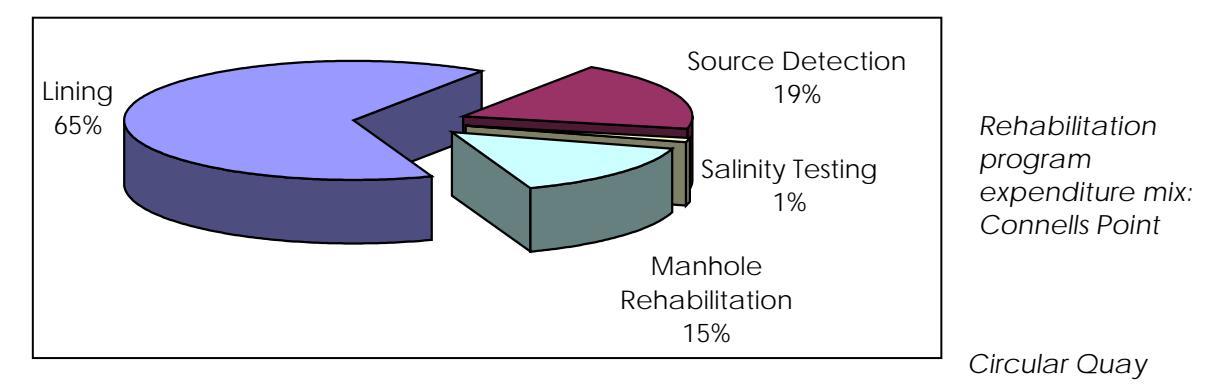
Most of the carriers along the shoreline were earthenware pipes. Salt water was entering through cracks in the pipelines and leaking joints. Extensive lining of the pipelines was needed. Manholes were mostly in reasonable condition.

Many of the pipelines and manholes were in difficult locations. Some were in the water, and others were in shorefront bushland accessible only by barges from the water.

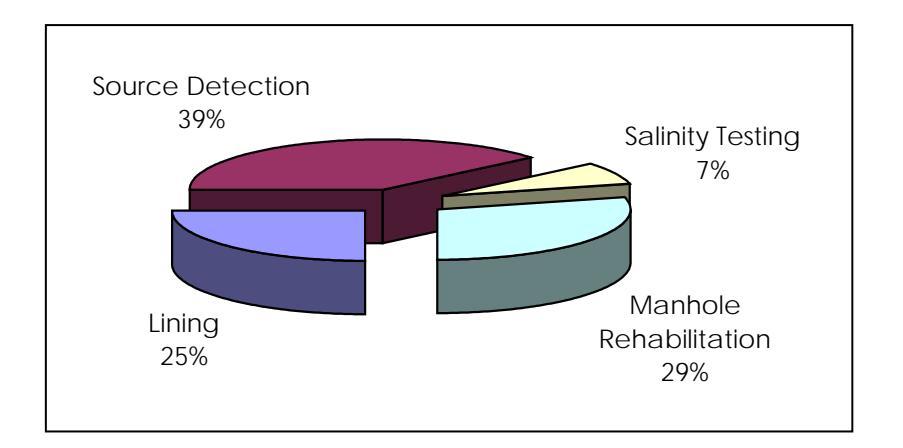
Rehabilitation program expenditure mix: Circular Quay

Investigation showed that a higher proportion of manhole rehabilitation was required compared to other catchments. At least one of the manholes was exposed to the sea and completely filled at high tide to the extent that flow measurement at that manhole was impossible.
