# Restoring 30m Deep Access Chambers With Interchem R

The Western Branch Main Sewer runs below the inner Sydney suburb of Ashfield. Interflow was awarded a tender to rehabilitate a section of the sewer main which also included renewal of 12 gas-attacked access chambers. The chambers were reaching the end of their service life. In most cases chamber surfaces had deteriorated to the extent that the aggregate was exposed.

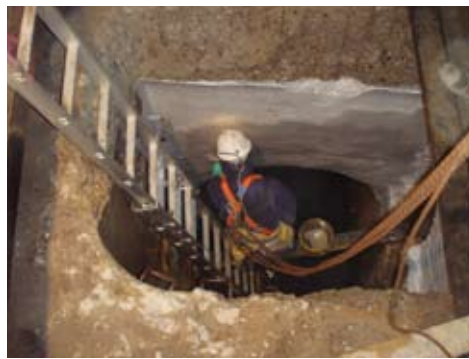
Temporary platforms were constructed inside the access chambers to enable working in deep depths.

The access chambers varied in depth from 4.5m to 33m with most chambers located below the natural water table. This meant that before any restoration work could commence the issue of infiltration had to be addressed. Leaks were plugged and sealed and at the clients request drainage ports were installed at various points along the structure walls.

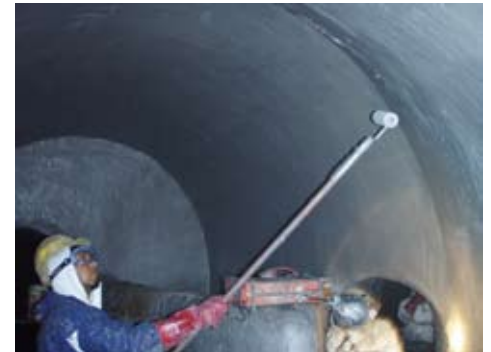
Whilst the primer was still tacky the epoxy – sand aggregate mortar was applied by trowel in a 10mm thick layer.

After cure a 2nd 10mm thick layer was applied to build a final thickness of 20mm on the access chamber surfaces.

The restoration was finished by applying 3 coats of epoxy glaze on the external surface. This provided the structure with additional protection against chemicals and abrasion.
