# Renewing Road and Rail Culverts in Western Australia

A recently completed contract saw Interflow renewing deteriorated corrugated metal and cast-iron culverts under roads and rail lines in a number of remote regions in Western Australia.

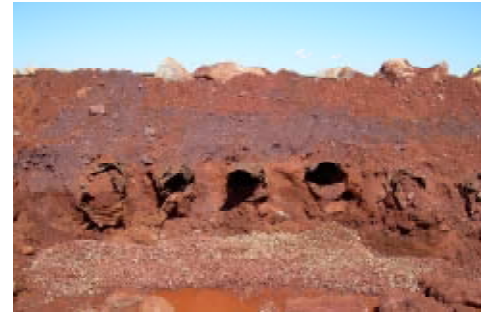
Many of the culverts were fully deteriorated with holes in the inverts that had led to cavities being formed underneath. This meant the liner had to be designed to be fully structural, taking all loads including road and rail traffic.

Deteriorated culverts prior to renewal with Expanda.

Interflow lined the deteriorated culverts with Expanda.

After installation of Expanda, cementitious grout was used to fill the gaps between the outside of the liner and the corrugations in the deteriorated culvert, as well as the holes that had been scoured in the inverts. Rehabilitation also included treatment of the exposed ends.

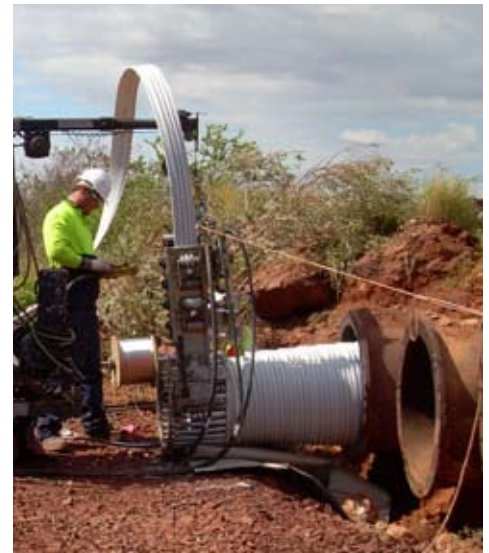
Expanda is a spirally wound-in-place pvc liner. The liner is supplied as strips of profile which are wound and locked together using a mechanical process.

Winding of the Expanda liner.

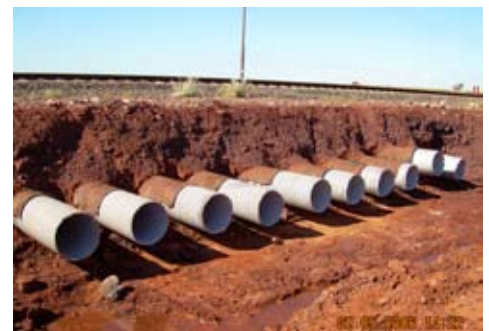
Culverts lined with Expanda prior to trimming of the ends.
