DESIGN OF LINERS FOR DETERIORATED SEWERS – LATEST RESEARCH TO MAKE IT MORE EFFICIENT

John Monro
Interflow Pty Limited

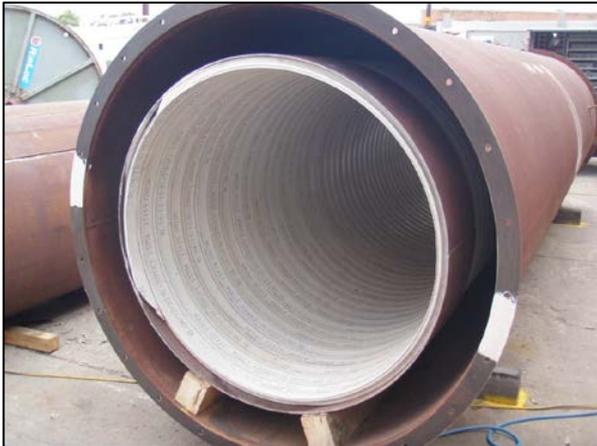
Picture 1: Assembly for the unsupported liner test, prior to placing the end sealing bungs. The Rotaloc liner is located centrally in the cylindrical pressure vessel

1. A cylindrical “pressure vessel” was fabricated with:
2. Internal diameter = 1,500mm
Length = 6,000mm
Wall thickness = 12mm
3. A Rotaloc liner with an external diameter of 1,200mm was wound into the pressure vessel. The liner was centred in the pressure vessel, supported by 2 wooden rails running along its length.

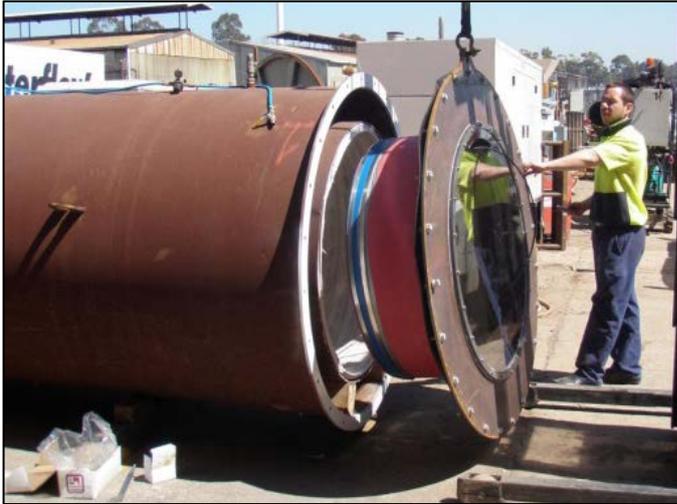
Picture 2: Installing the sealing bungs at the end of the liner

4. Steel end rings were placed around the ends of the Rotaloc liner to allow assembling of the sealing bungs. (See Pictures below)
5. The sealing bungs were placed around the ends of the liner, bolted to the flanges on the pressure vessel. This provided a water-tight space between the outside of the liner and the inside of the pressure vessel.

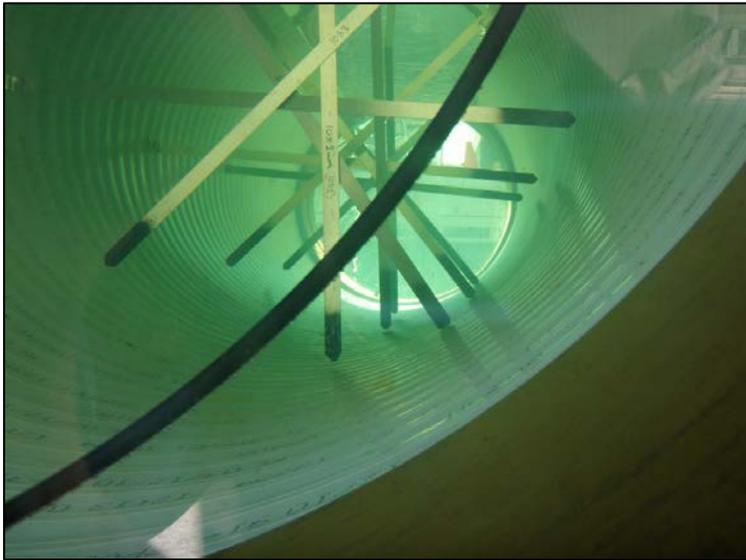
Picture 3: The inside surface of the liner is just touching the indicator bars, showing that the liner has deflected by 3%. For the purposes of the test, this was taken to indicate that the liner had buckled.

6. Indicator bars were hung inside the liner in 3 positions and in 4 planes at each position. The bars were hung so that the liner would contact the end of one of these bars when its deflection reaches 3%. See Picture 3. This 3% deflection was taken as “buckling failure” to provide a consistent point for comparison in each of the test scenarios.

Pressure was increased until deformation in the liner reached a stage where the inner surface just touched an indicator bar. This occurred at a pressure of 30 kPa.

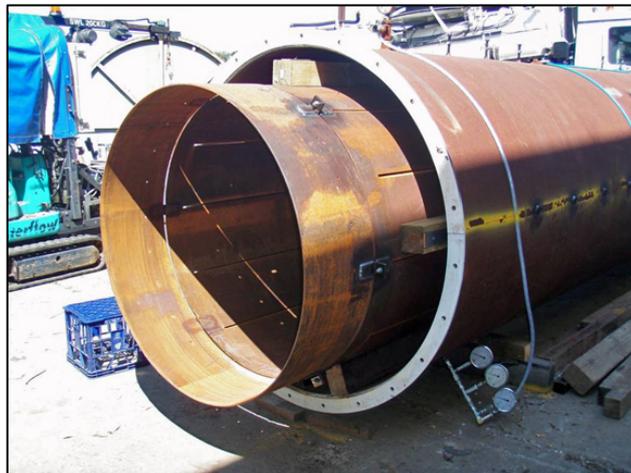
Picture 4: Steel tube fabricated to support the Rotaloc liner to be wound inside it. Slots were cut in the tube to allow hydrostatic pressure to be applied to the liner.

A steel tube with an internal diameter of 1,200mm, composed of 6mm steel plate was fabricated in a length of 6 metres. Slots were cut into the tube running longitudinally and spaced around its circumference. (See Picture 4)

The tube was required for use in both the ungrouted and grouted liner testing, with the slots allowing hydrostatic pressure to be applied to the liner.

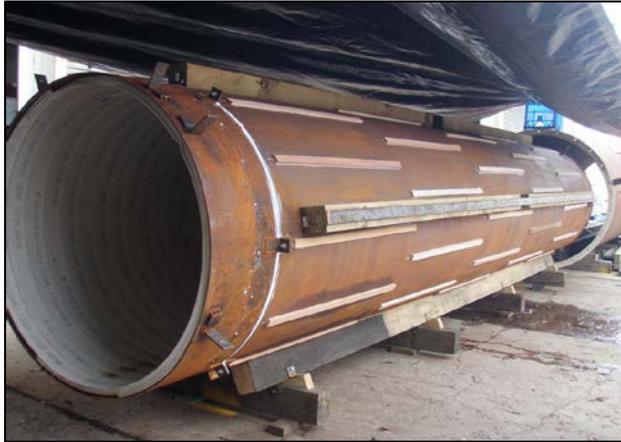
Picture 6: Slots in the steel tube covered while the liner is grouted. The covers were removed prior to it all being inserted into the pressure vessel for testing.

Following the testing of the ungrouted liner, the steel tube was removed and the slots covered.

Following curing of the grout, the covers over the slots were removed and the liner and its steel tube were re-inserted and re-centred in the pressure vessel. Removing the covers from the slots was necessary to allow the hydrostatic pressure to be applied to the grouted liner.
