Lower Murray Water

Maintenance Hole
Rehabilitation

Mildura, VIC

RENEWING MILDURA'S DEEP MAINTENANCE HOLES

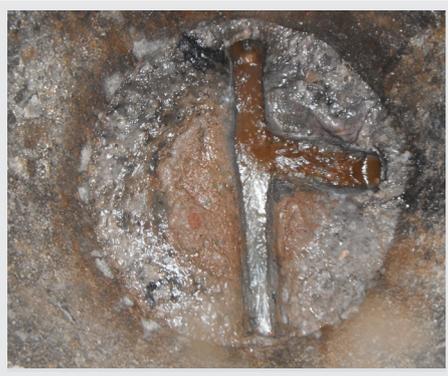
Before: Image shows maintenance hole deterioration caused by sewer gases

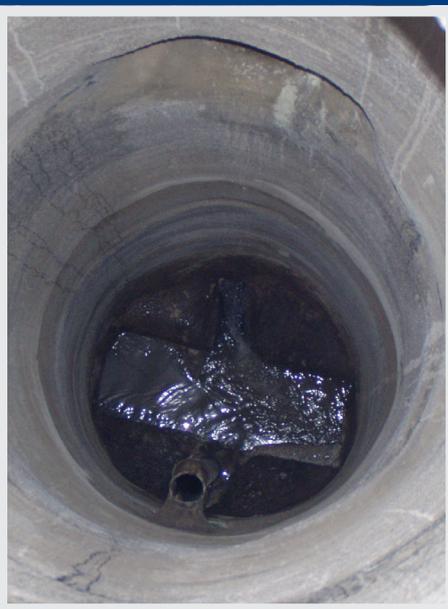
After: Maintenance hole restored to structural capacity using Interchem® CAC, an acid resistant inner coating.

The Calcium Aluminate Cement (CAC) wall required two layers of steel mesh reinforcement. Anchor holes were drilled in the remains of the existing maintenance hole wall in a grid with spacings between 400mm and 600mm.

Reinforcing bars cut to lengths of 120mm were epoxied into these holes to a depth of 50mm. Reinforcing mesh was tied to these epoxied bars.

Temperatures during the day approached 40°C. Coating was carried out at night in cooler conditions to guard against the CAC curing prematurely in the heat. Spraying of Interflow's Interchem® CAC mortar was undertaken in three layers to build up the specified thickness of 90mm. The reinforcing bars provided a guide to the applied thickness.

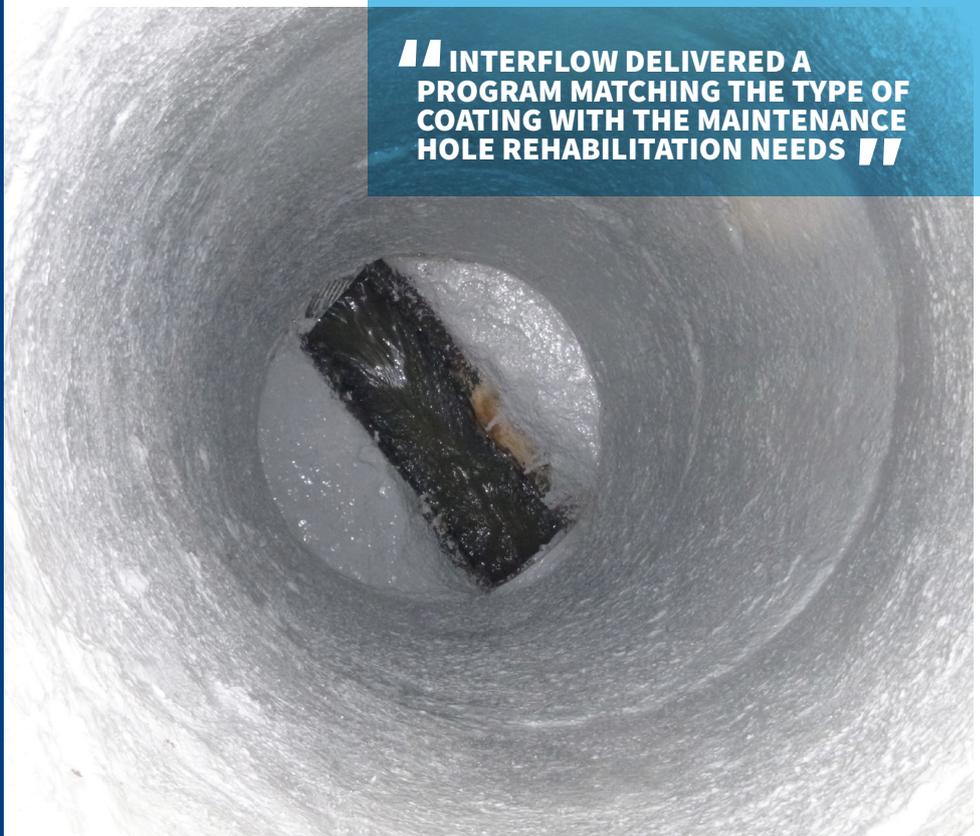
INTERFLOW DELIVERED A PROGRAM MATCHING THE TYPE OF COATING WITH THE MAINTENANCE HOLE REHABILITATION NEEDS

The two maintenance holes requiring re-building were over 10 metres deep, located in the roadway near the Quality Hotel Mildura Grand, a Mildura landmark. It was proposed to re-build these maintenance holes with steel reinforced calcium aluminate cement to provide structural strength and corrosion resistance.

A vital part of any maintenance hole coating project is thorough cleaning to remove all acid attacked concrete. On this project, cleaning was completed using a 25,000 psi hydro-demolition unit which ensured the surface was cleaned under strict safety procedures to a suitable condition to be coated.

An internal scaffolding tower was erected to allow safe access in the deep maintenance hole. This was a considerable achievement in a maintenance hole with an internal diameter of only 1.2 metres.
