Water Mains Rehabilitation

Acland Street, VIC

03-POT-SACL01

**RAPID MOBILISATION AND
EFFECTIVE COMMUNICATION HELPS
STREETScape UPGRADE OPEN ON
TIME**

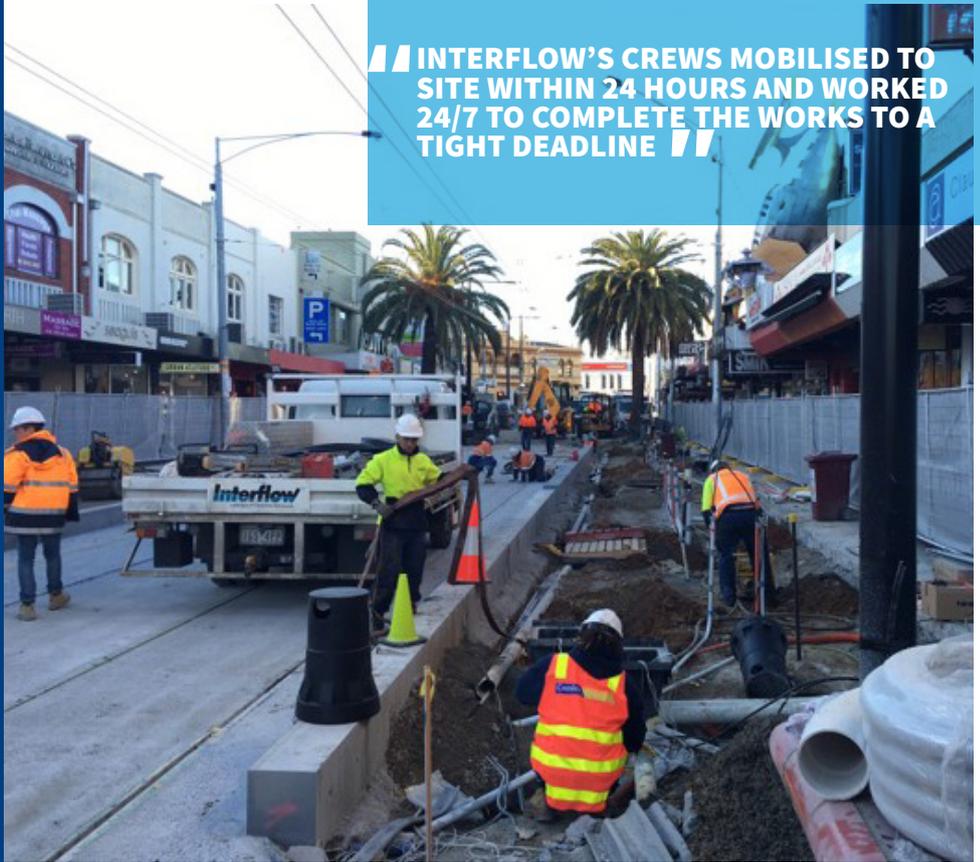
INTERFLOW'S CREWS MOBILISED TO SITE WITHIN 24 HOURS AND WORKED 24/7 TO COMPLETE THE WORKS TO A TIGHT DEADLINE

Excavation to replace cast iron water mains

With temporary supplies provided, Interflow crews worked 24/7 to replace the aged cast iron pipework. While some excavation was needed, it was minimised by pipebursting and installing polyethylene pipe along the routes of the old pipelines.

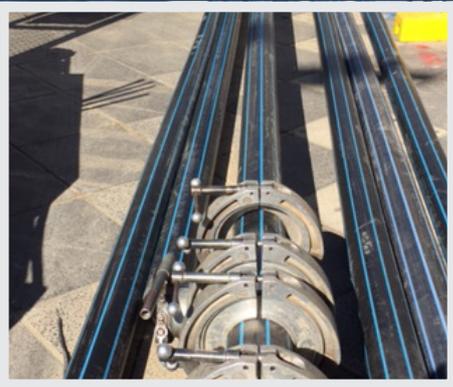
Butt welding of polyethylene pipes
