Napier City Council

Sewer Rehabilitation and
Pressure Testing

Napier, New Zealand

17-WAS-NAP001-007

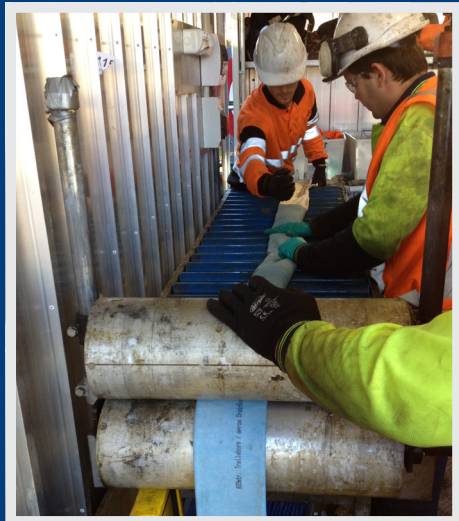
Crew preparing the Interflex® liner

Following SPR™ EX - Expanda Pipe lining of the main sewers, Interflow's cured-in-place Interflex® liner was installed in the private sewers, which came in a variety of materials.
