BRICKS, BENDS AND BYPASS – DESIGN AND EXECUTION CHALLENGES FOR THE NORTH YARRA DEVIATION SEWER REHABILITATION PROJECT

Matthew MacDonald¹, Andrew Hackett¹ and John Monro²

¹ John Holland-KBR Joint Venture, Australia

² Interflow Pty Limited, Australia

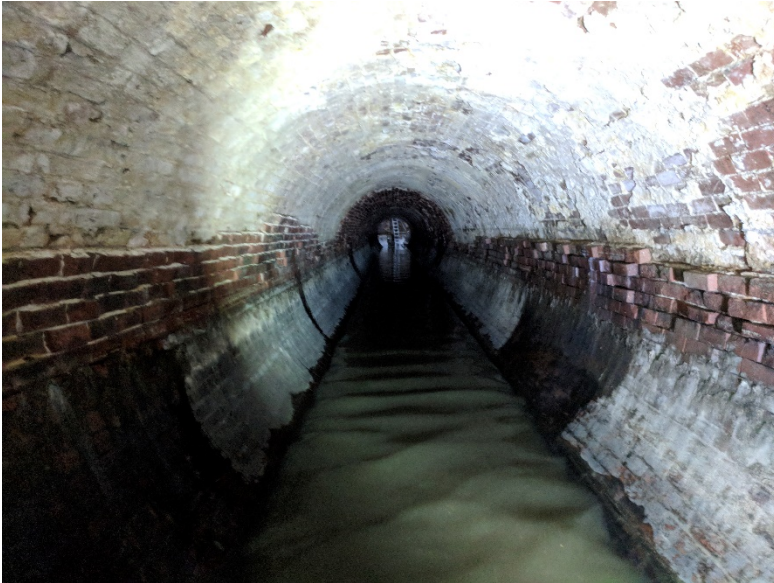
Figure 1: Standing in sewer within existing brick section after cleaning.

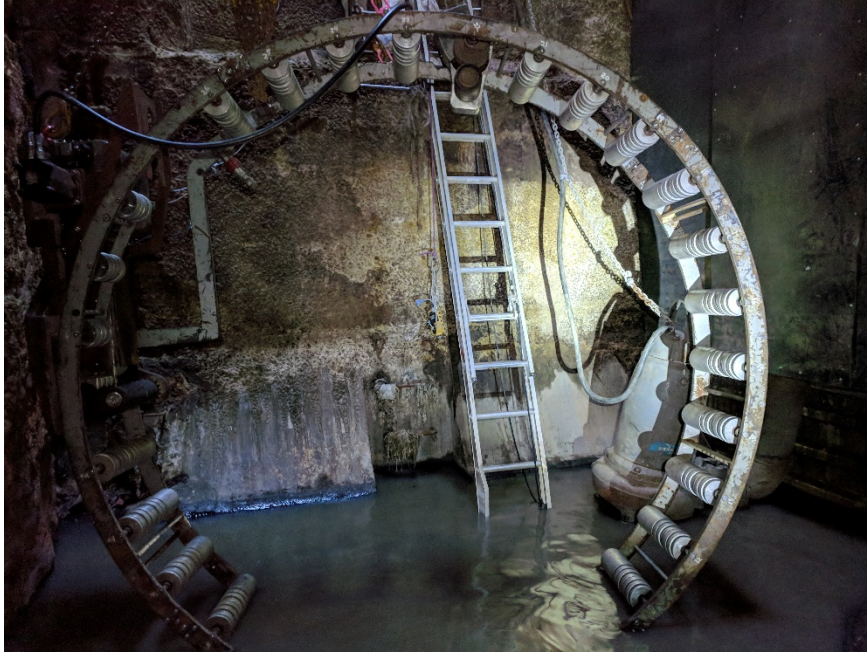
Figure 2: Ribline machine positioned in sewer.

Ribline, an Australian developed steel-reinforced polyethylene liner from Sekisui Rib Loc Australia was selected as the preferred option. It has been used for trenchless renewal of deteriorated large diameter pipelines and culverts, initially in Australia and then around the world.

Calculation in accordance with international standards for sewer relining including adjustments based upon the verified condition of the asset confirmed that the installed Ribline liner has sufficient strength to withstand all loads on the sewer, assuming the existing structure is fully deteriorated with no remaining strength.

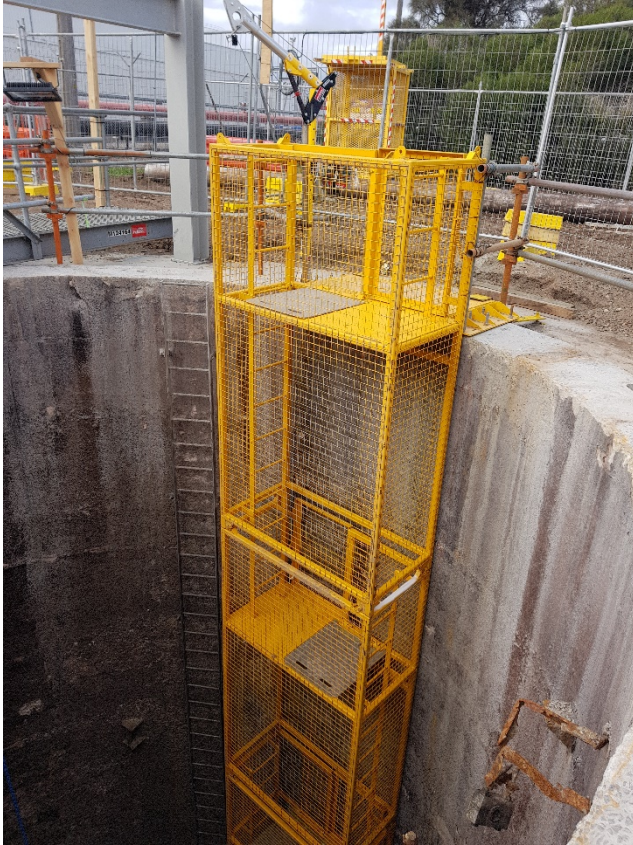
Figure 3: Caged safety ladder in situ in manhole.

Approximately 75 per cent of the work was completed in confined space. John Holland systems and processes were implemented to ensure confined space was managed to industry best practice levels. Additionally, an innovative temporary access stair cage was installed - which had been developed in previous John Holland tunnelling projects – that provided increased safer access with no need for davit arm and harnesses.

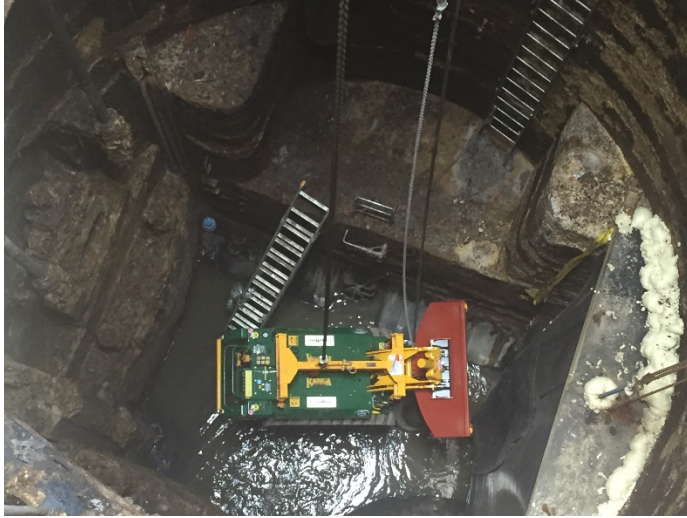
Figure 4: Kanga lifted into manhole

Typically, silt is removed from sewers by high-pressure water jetting, and for large sewers, by manual methods involving shovels and carts. For this project, Interflow further developed a "Kanga" loader that allowed safer and faster silt removal.

A wheeled, open-ended, removable container, shaped to match the tunnel invert was attached to the front of the Kanga and pushed up the sewer collecting silt as it goes. When full, this container was transported back to the access chamber. The removable container was then lifted to the surface by crane and the silt deposited securely in a sealed bin ready for transportation off-site.

The remote-control system of the Kanga, allowed the it to be operated from the base of the access chamber, without an operator needing to access the deteriorated sewer.

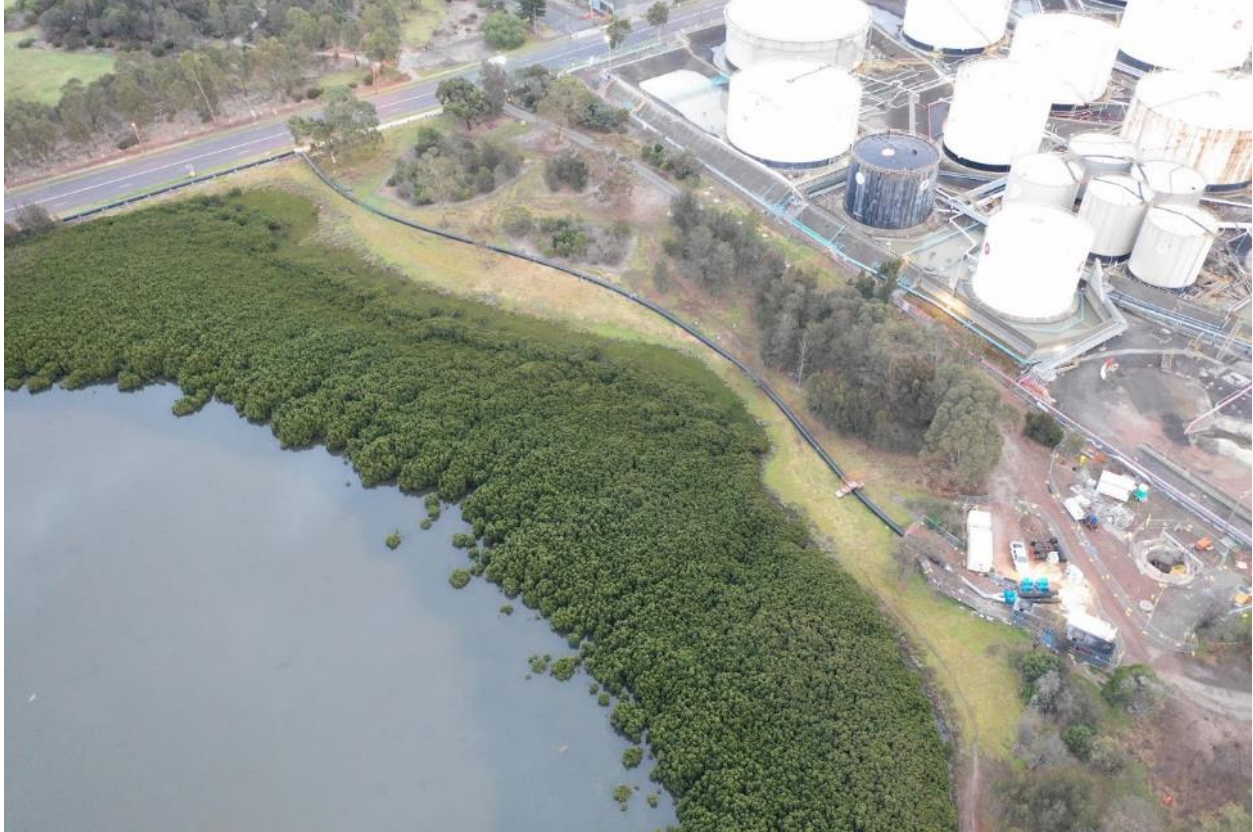
Figure 6: Stony Creek Backwash with adjacent bypass pipeline.

The project team and Welltech investigated alternate routes and identified the opportunity to lay the pipe along Hyde St adjacent to the bike trail and under the West Gate Bridge to Manhole NYM001C. VicRoads and Bicycle Network input was provided to guide the location of the pipe providing ease in approvals and a route that avoided sensitive cultural heritage areas.

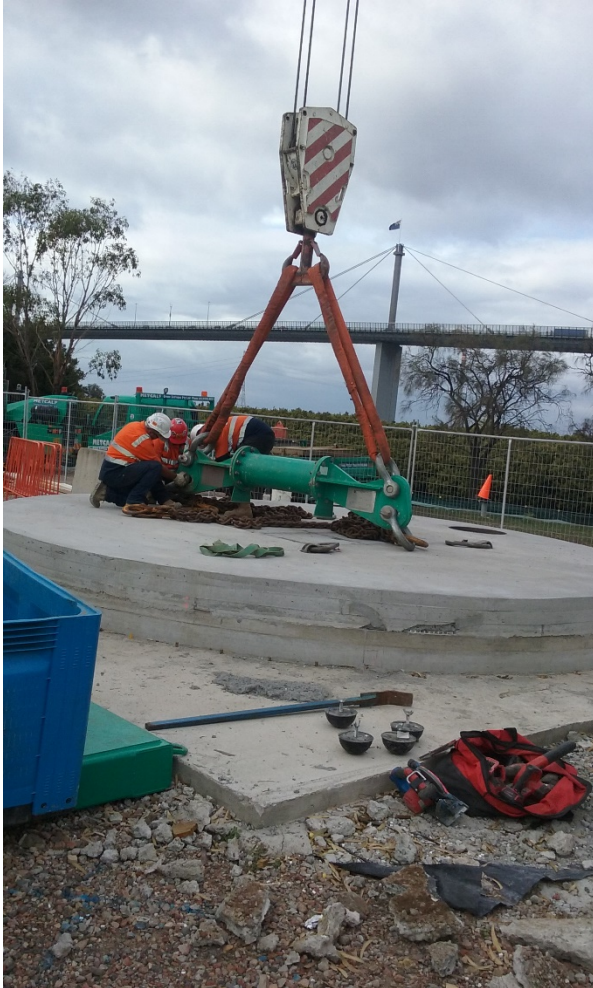
Figure 7: new manhole cover after lift onto manhole.

Manhole (NYM003A) lid was removed to aid access and ventilation during the works. To reinstate a new lid the project team identified it would cast the lid in one piece onsite and lift into place. This allowed the team to significantly reduce the time working near the manhole, eliminating live edges and fall from heights, removed the need for a wide load transport on roads and the 6m diameter lid was safely installed onsite in one piece. The efficiency saved time for the project. Additionally, the lid was designed to precast a HDPE liner underneath the lid to increase its asset life.
