TRENCHLESS REHABILITATION OF CITY OF GOLD COAST'S DN600 SEWER RISING MAIN

Will Zillmann¹, Christian Truscott² and Geoff Spencer²

ABSTRACT:

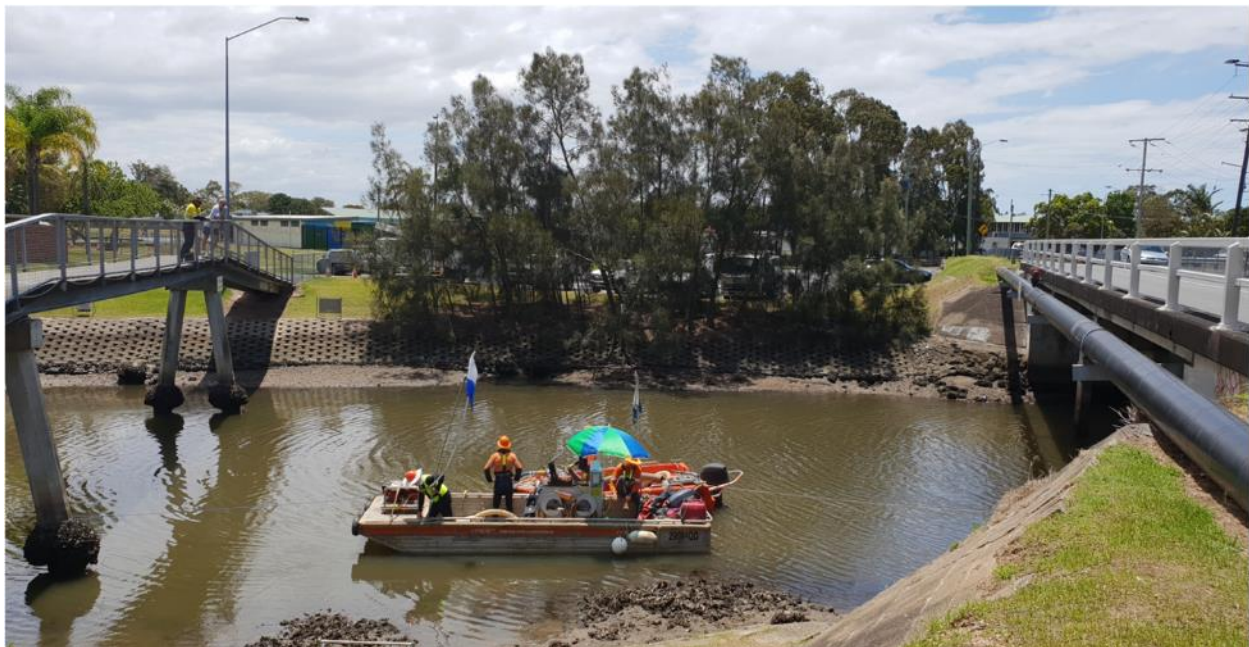
Figure 2. Diving investigations on the Eastern Force Main crossing of Biggera Creek

As the main was encased in concrete and covered in large rocks, the dive teams found it difficult to ascertain the point and mode of failure. At that point it was decided that a repair method must be developed which could cater for a range of failure scenarios. Under Eastern Force diversion conditions there was a significant risk of potential overflow from surcharge events during wet weather so the repair of the Eastern Force Main necessitated a solution that could meet a very tight schedule.

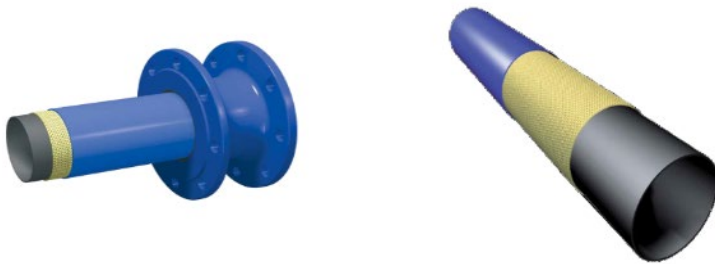
Figure 6. The Primus Line® system consists of a flexible, high-pressure liner and patented end fittings

The Primus line® system is a trenchless technology for the rehabilitation of pressure pipelines consisting of a flexible, high-pressure liner and patented end fittings. The Primus Liner has the capacity to withstand the full maximum allowable operating pressure (MAOP) within a given pipeline subject to any de-rating that may be required due to bends. While possessing sufficient ring stiffness to be self-supporting when de-pressurised the liner has insufficient ring stiffness to withstand external dead and live loads in its own right.

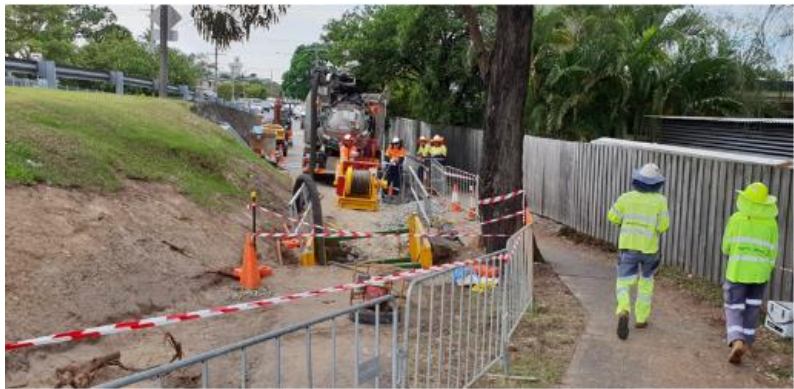
Figure 10. Southern end of the Eastern Force Main – the need to maintain pedestrian access around the site was critical

Gaining access to both ends of the pipeline was difficult and heavily constrained due to the need to maintain pedestrian access around the construction site. The site was also congested, particularly on the southern side of the creek, with presence of a Trunk Water Main, stormwater drainage, a significant tree and a bridge abutment in the same corridor as the Eastern Force Main. In addition, with only 75m of Primus Line available from SW, the location of the cut in points to the main was critical.

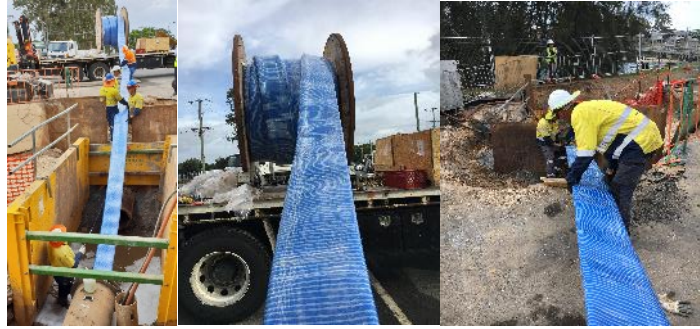
Figure 11. The pre-folded Primus Liner is winched and guided into place

Once the pre-folded Primus Liner was winched into place, pressurisation was required to break the restraining wrap which were installed at the factory, and to inflate the liner to its full diameter ready for attachment of the propriety flanged connectors.

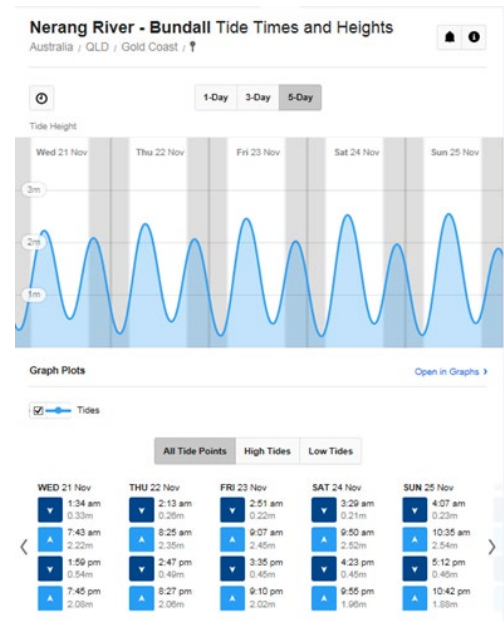
Figure 12. The incoming tide had a major impact on the available work window

The issue now was the rapidly rising water table as the tide came in. There was only a three hour window from low tide to the water table covering the pipe obvert. The very narrow working window meant the installation of the connectors was required to be staged from one shift to the next to accommodate the 12 hourly tidal cycles. At the end of the first shift only one connector was fully installed and bolted together. The other connector was only partially installed and it was thought that the work that had been done would be sufficient to stabilise the work until the commencement of the next shift. The down side was that as the tide came in, the partially prepared connector was subject to significant hydrostatic force which had the net effect of de-stabilising the liner within the connector, which required rectification. The team not only managed an innovative and successful repair, but the entire Primus Line installation, which commenced at 4.00am on the Tuesday morning, was completed by Wednesday night after four separate shifts.
