CASE STUDY

Stormwater Investigation and Relining

## INVESTIGATION AND RELINING ON A RAAF BASE AT NIGHT

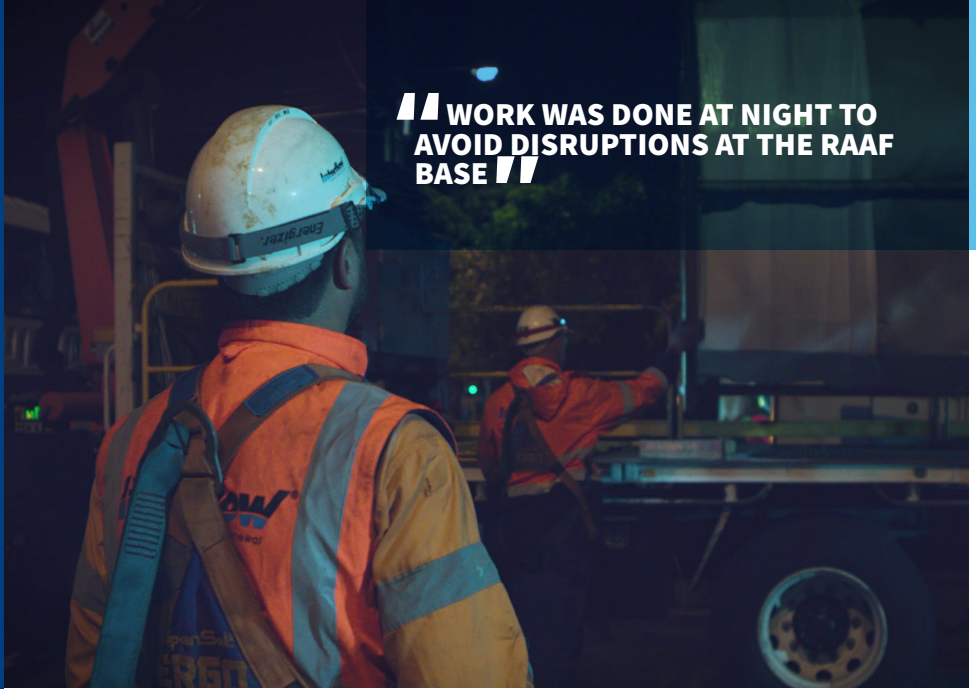
Installation of an SPR™ EX - Expanda Pipe liner in a deteriorated stormwater pipeline

Interflow carried out this project by installing structural liners in the deteriorated stormwater pipelines. Investigation showed considerable preparation work was needed before the liners could be installed.

Ground stabilisation was needed to fill voids after liner installation. This required a large volume of expanding foam. Some 200 tonnes of silt was also removed from inside the pipelines and partly used to fill all the sinkholes.
