Pressure Main Rehabilitation

Victoria Street, Coffs Harbour

## PROBLEM WATER MAIN QUICKLY RESTORED WITH PRIMUS LINE

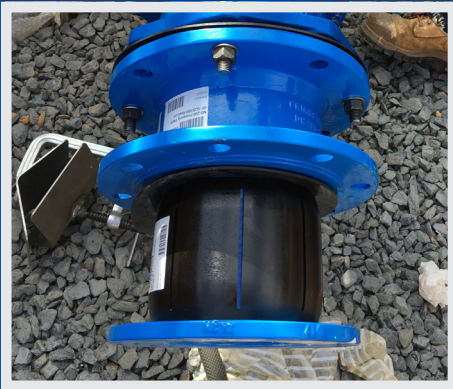
Primus Liner end cap

Following disinfection, the Primus Liner was connected to the existing main by patented Primus Line fittings, with a new scour valve being installed in the intermediate pit.

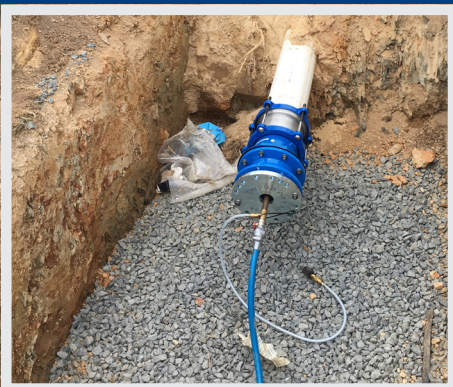
Primus Liner end capped for inflation and curing
