**Interflow**<sup>®</sup>

**CUSTOMER**  
Coliban Water

**PROJECT NAME**  
Emergency Repair and  
Relining

**LOCATION**  
McIntosh Street, Echuca VIC

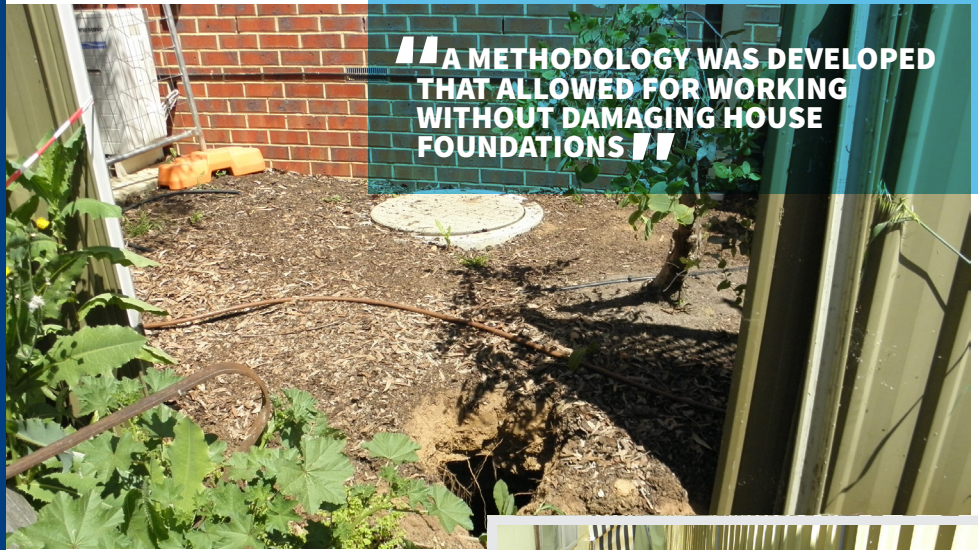
Large voids were appearing in the narrow access path between two houses. The voids were potentially undermining the foundations of both.

Internal CCTV inspection showed that a section of the sewer running between both houses had collapsed. The sewer was six metres deep. Roots were entering from other cracked and leaking joints along the line.

Interflow proposed excavating and replacing the damaged section, then installing a structural SPR™ EX - Expanda Pipe liner to renew the full length of the rest of the sewer.

Extensive root removal from the sewer was necessary before internal CCTV inspection could be carried out. Once CCTV had identified the location of the collapsed section, it was exposed using hydro-excavation and hand digging. Timber shoring was installed to ensure the excavation did not collapse. The collapsed section of sewer was replaced with UPVC sewer pipe and embedded in stabilised sand.

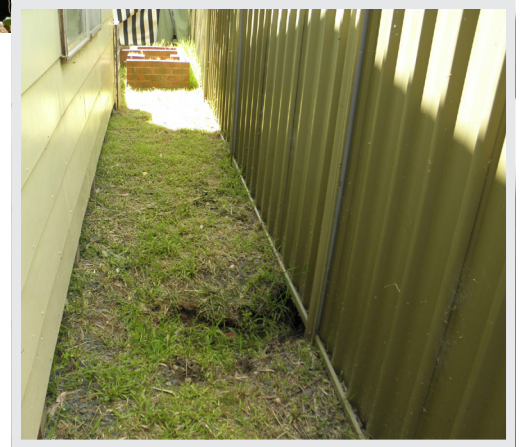
Partial sewer collapse was considered responsible for ground subsidence that was undermining house foundations. The tight location on a path between the two houses meant problems with the deep excavation needed.

*Depression visible midway along the trench*

The entire sewer was then lined with SPR™ EX - Expanda Pipe liner, installed from existing maintenance holes.

Site restoration included backfilling of the excavation with a pumped cement stabilised slurry with the timber shoring left in-situ.

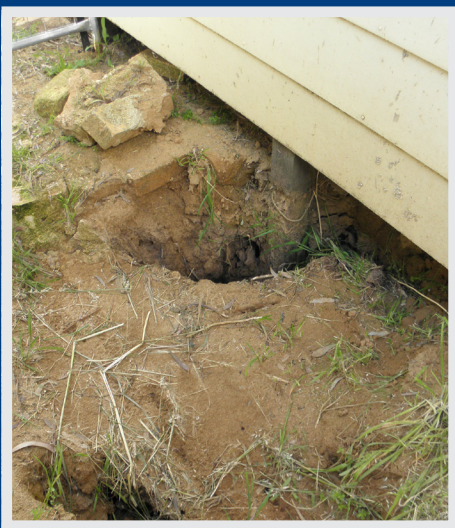
*Exposed stump under one of the properties*

A feature survey was conducted on the houses to ensure there was no movement/sinking during the works.
