Larkin Lane

25-WAS-LIS001-010

**WORKING 'OUTSIDE THE BOX'  
IN A NARROW SPACE**

Interflow repairs 100-year-old sewer pipe in bustling Lismore laneway

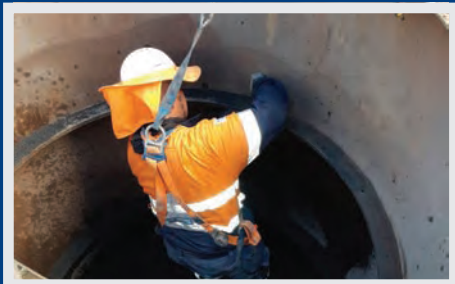
Steel casing tube being bolted together

After preparing a geographical report of the area to develop the methodology, Interflow installed a custom-designed steel casing tube to stabilise the area and reinforce the underground structure. This provided security to the outer maintenance holes and eliminated potential disruption to the trench caused by the surrounding buildings.

Due to the confined space, a large excavator could not be used, so Interflow used a smaller six-tonne excavator to lift each section of the tube and bolt them together.

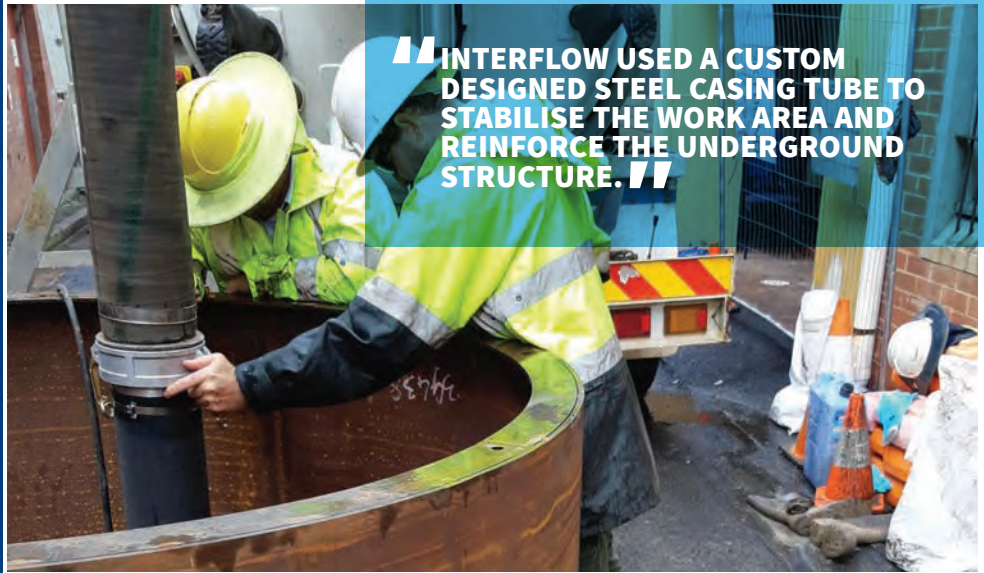
INTERFLOW USED A CUSTOM DESIGNED STEEL CASING TUBE TO STABILISE THE WORK AREA AND REINFORCE THE UNDERGROUND STRUCTURE.

Interflow used a custom-designed steel casing tube to stabilise the work area and reinforced the underground structure. Its 'hoop strength' was strong enough to resist the ground pressure from the soil and withstand any weight imposed on the trench.
