Rehabilitation at Moa Point

Critical asset inspection leads to durable solution

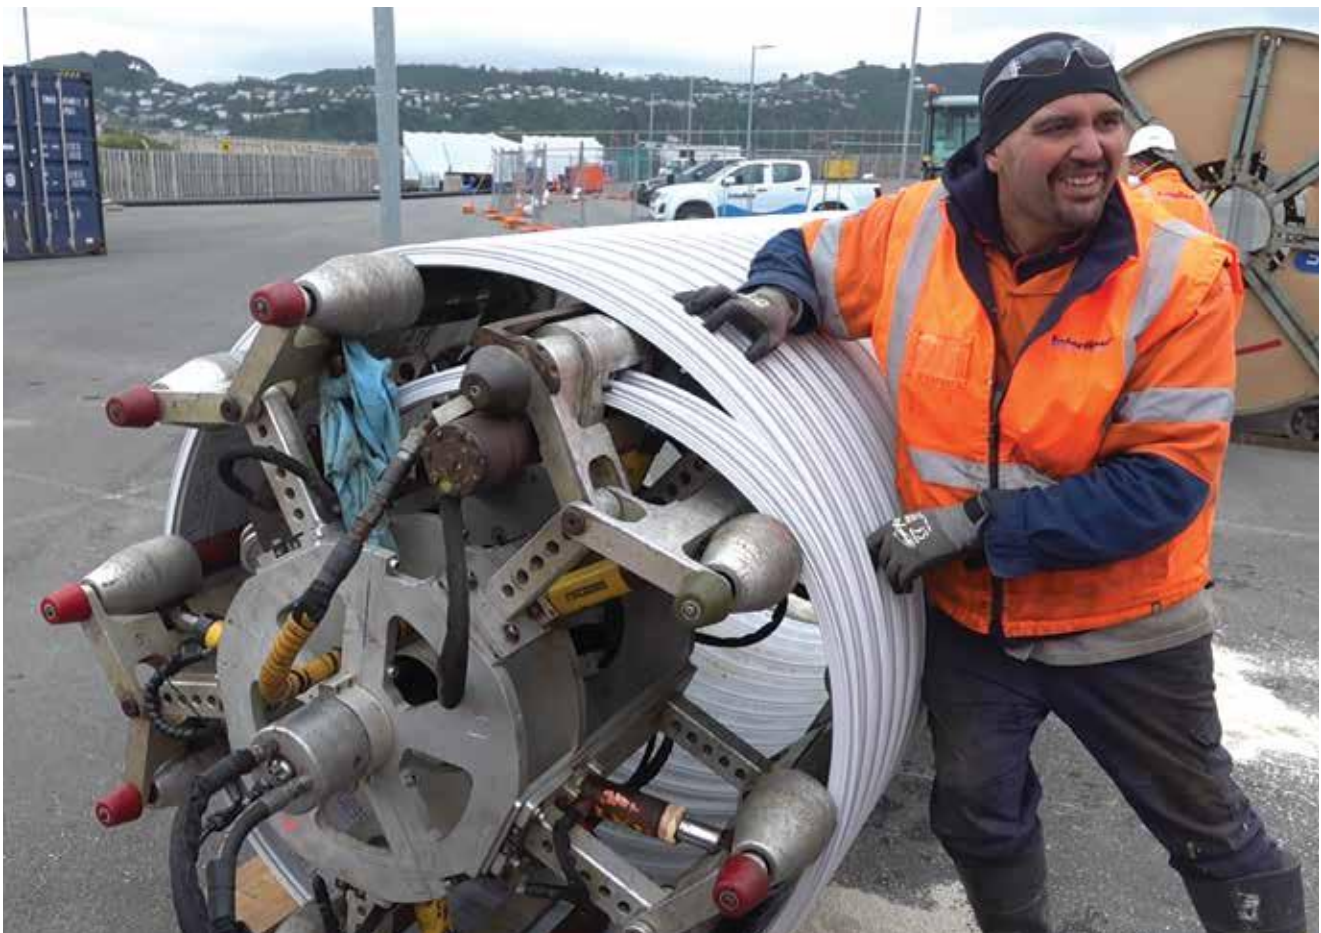
An above-ground demonstration of the pipe lining machine by Adam, a foreman for our contractor, Interflow, showed how the plastic compound spirals forward and is glued into place as it advances through the host pipe.

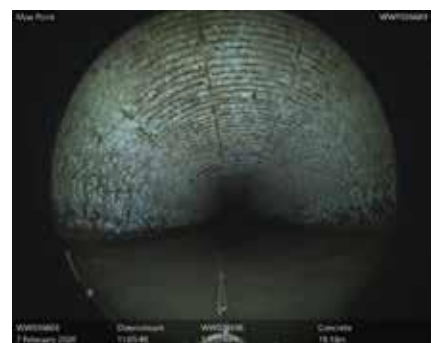
The project was fast-tracked after an inspection of a section of the main pipe which carries Wellington's wastewater to Moa Point for treatment—known as an interceptor—revealed internal corrosion exposing reinforcement bars.

A CCTV view of the interceptor's reinforced concrete interior revealed corrosion caused by hydrogen sulphide.

In a trenchless operation, a section of wastewater pipe near Moa Point Wastewater Treatment Plant has been lined to increase resilience and maintain reliability.

Interflow's Project Manager, Saadia Ali, said the material used to line the interceptor was PVC. Concrete grouting was then injected between the original pipe and the new liner. “PVC has a proven service life of 70-plus years in aggressive sewerage conditions, so this is a durable, long-term solution.”

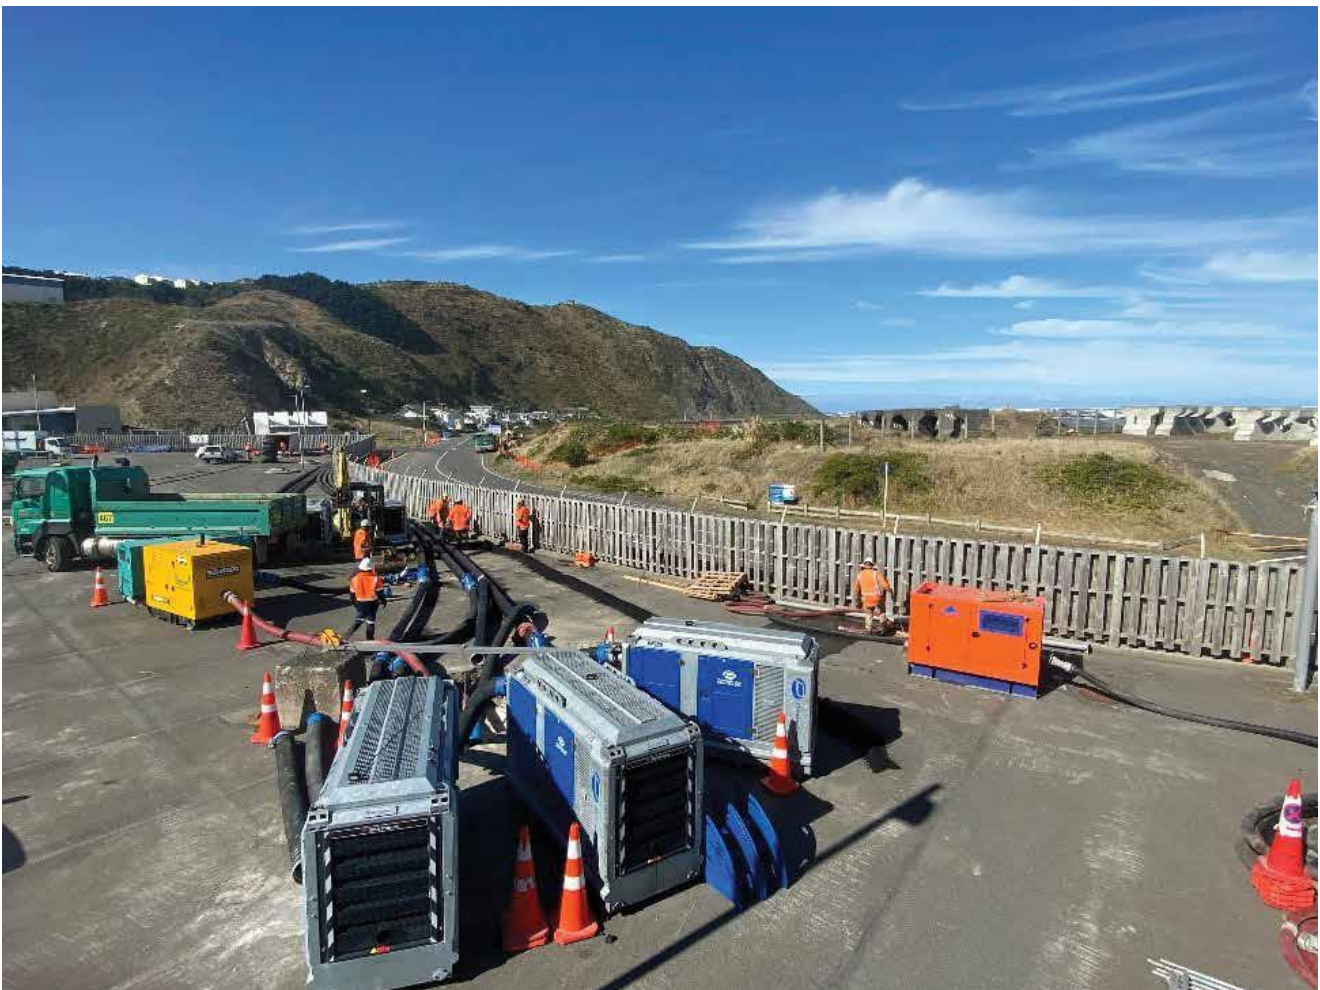
Before the damaged section of the tunnel could be fitted with the new corrosion-resistant lining, it was over pumped, which means the wastewater flowing through the interceptor was diverted in order to allow the lining machine to operate within the pipe. The over pumping was undertaken on behalf of Interflow by local contractor EN Ramsbottom.

Pumps and temporary piping were used to by-pass the corroded section of pipe.

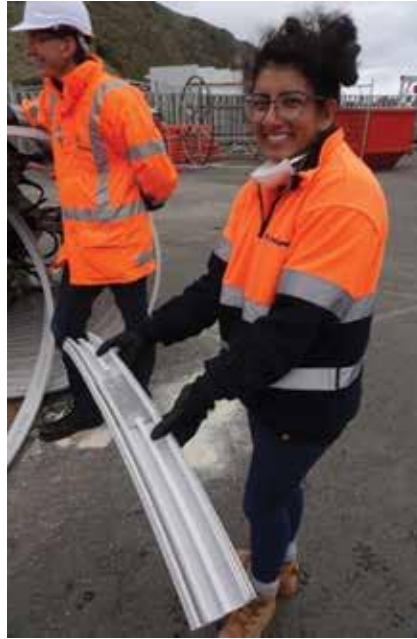
A durable, long-term solution: Saadia Ali with a section of the PVC used to line the interceptor.
