Merewether Beach ERS Rehabilitation

The Merewether Beach relining project rehabilitated 130m of an ovoid wastewater Emergency Relief Structure. Faced with the environmental challenge of managing the tides, Interflow used cofferdams to ensure their CIPP solution could be successfully installed.

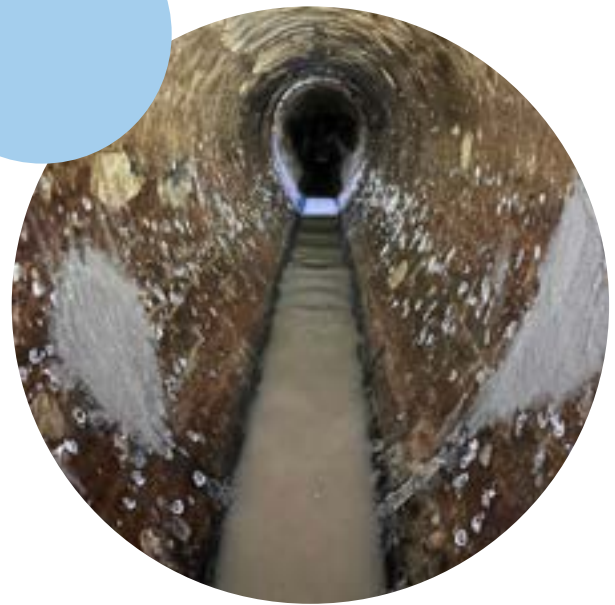
A new CCTV inspection of the ERS revealed that the downstream sections of the pipe were in poor condition and cracks along the pipe wall were allowing sand in. This was exacerbated by the oviform shape, slope, and lack of non-return valve of the pipe, meaning sand accumulation within the pipe was inevitable.

The primary objective of the project was to reduce sand infiltration into the system by relining a 130m section of pipeline.

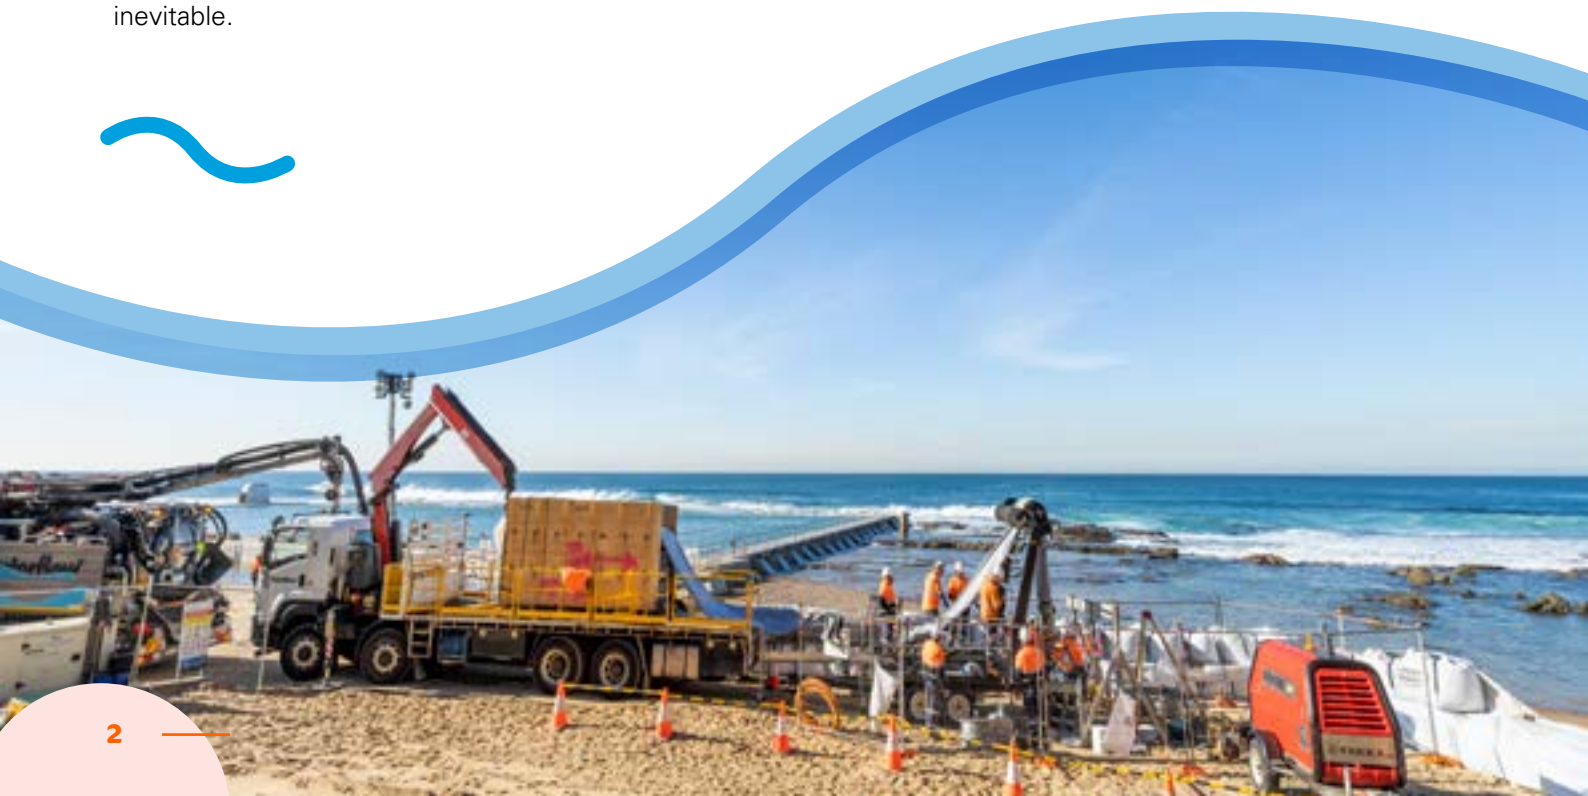
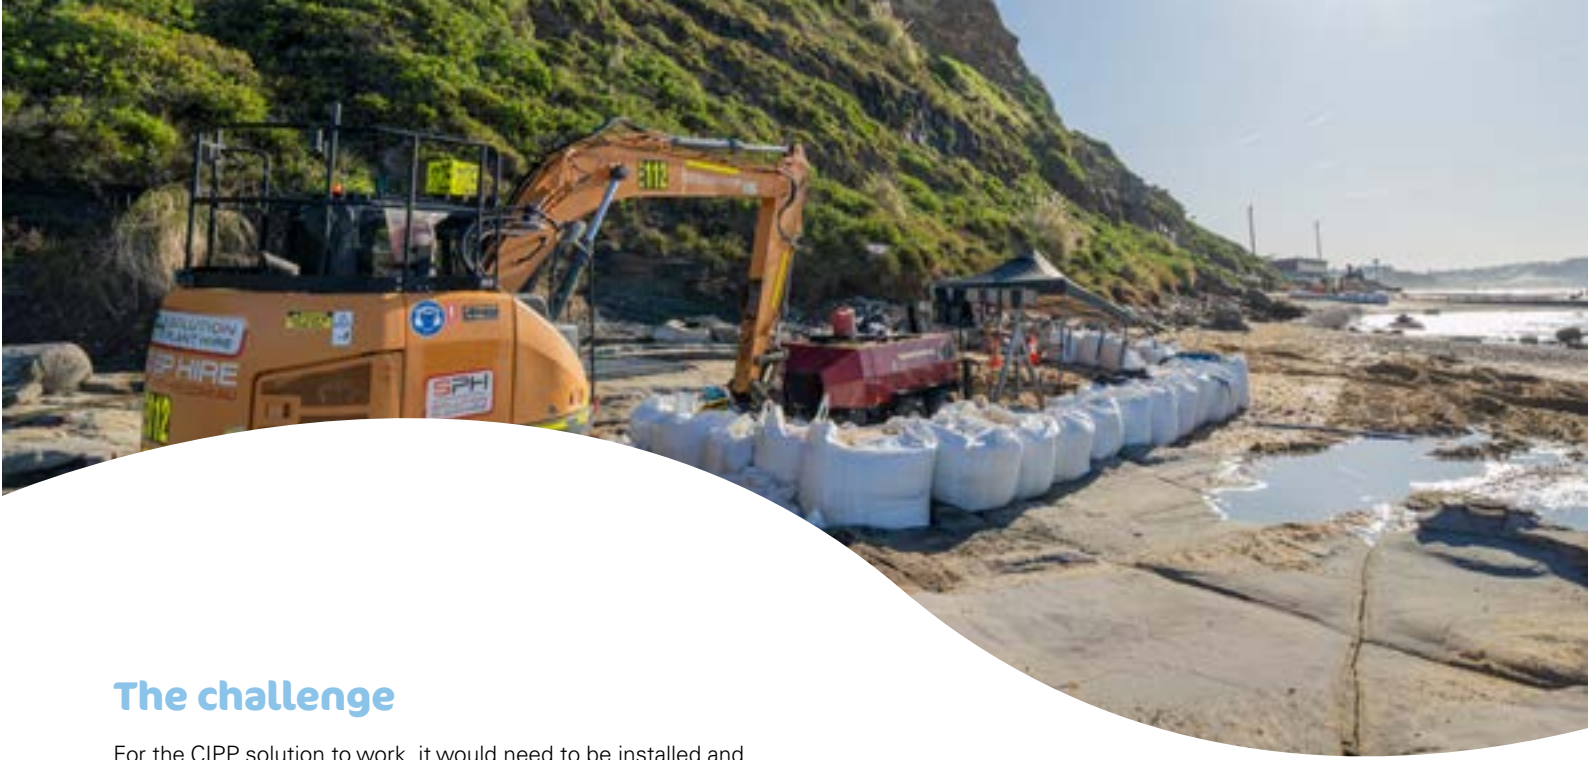
Our crew installed sandbag cofferdams to minimise the chance of water affecting the relining process. Once in place, water was then pumped out of the pipe, allowing both the cracks to be sealed and the pipe to be cleaned prior to lining. Following this preparation, a UV-cured CIPP liner was used to restore the pipeline.

Each access hole also had a cofferdam built around it made from smaller sandbags as added protection from tidal surges.

A dam wall was built using one tonne sandbags. Unfortunately, higher than anticipated overnight swells all but washed the wall away and the team was forced to start again. In the end, across the two dam walls, one at each end of the pipe section, 100 tonne of sand was needed to build a wall big enough and strong enough to control the tide.
