CASE STUDY

Port Macquarie-Hastings  
Council

Stormwater Pipe  
Rehabilitation

## LINING TO A SUBMERGED OUTLET

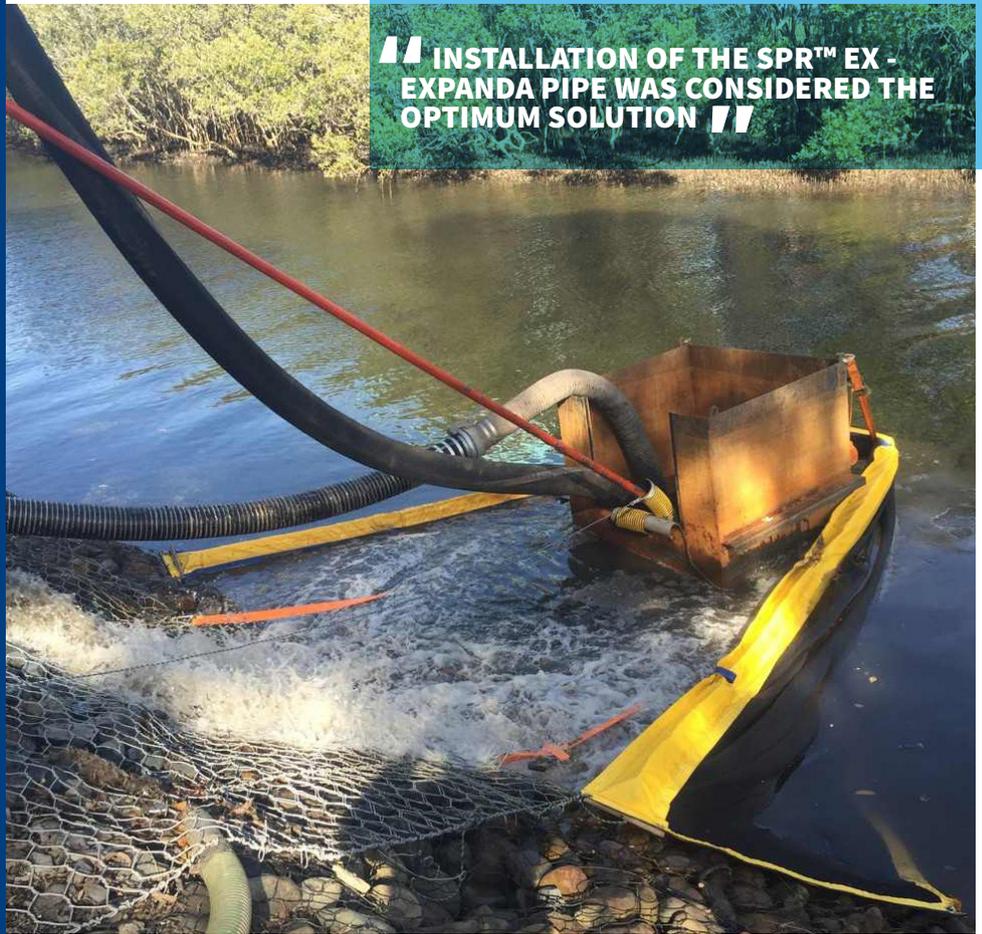
INSTALLATION OF THE SPR™ EX - EXPANDA PIPE WAS CONSIDERED THE OPTIMUM SOLUTION

The liner was installed from the dewatered coffer dam. As SPR™ EX - Expanda Pipe is mechanically expanded during the installation process, it was able to efficiently handle the variations in diameter along the pipe length. Installation does not block the pipe and heating is not part of the process, so work could be undertaken in working hours limited by low tide with the liner partially submerged.

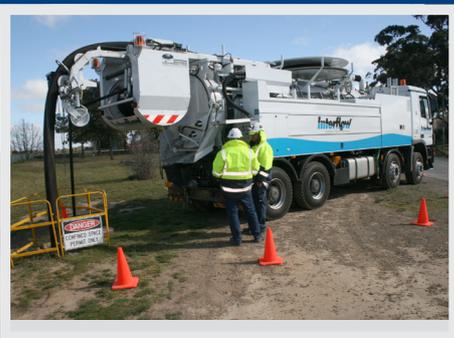
Heavy cleaning was necessary to remove the oyster colonies encrusted inside the pipe.

Super 2000 combination recycling jetter truck
