Interpatch Provides Cost Effective Pipe Repair in Caloundra

Sewer pipelines that have suffered isolated damage such as a crack or a leaking joint may otherwise still be in acceptable service condition so relining the entire pipeline is not economical. Interpatch can be used to cost-effectively repair localised sections of pipe directly at the location of the defect.

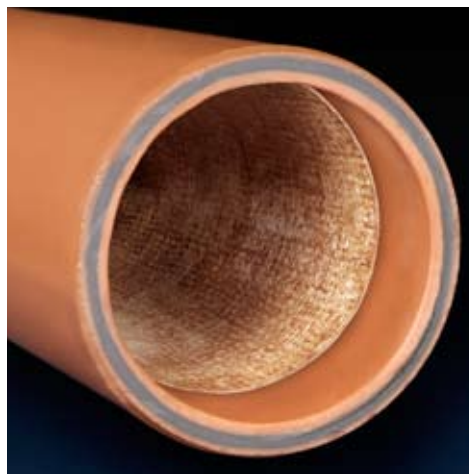
In all, 214 Interpatches were installed across a total pipe length of 5.8km in diameters between 150mm and 450mm. The Interpatches provided a cost-effective solution to repairing and sealing spot defects.

Interpatch can be installed in pipe diameters from 100mm to 750mm. and the wall thickness of the patch can be varied to suit specific loading requirements. It can be installed in live-flow conditions from existing access chambers without exaction so there is minimal disruption to community.
