# Technology that has all senses covered

by Paul Chalhoub, Products Manager, Interflow Pty Ltd

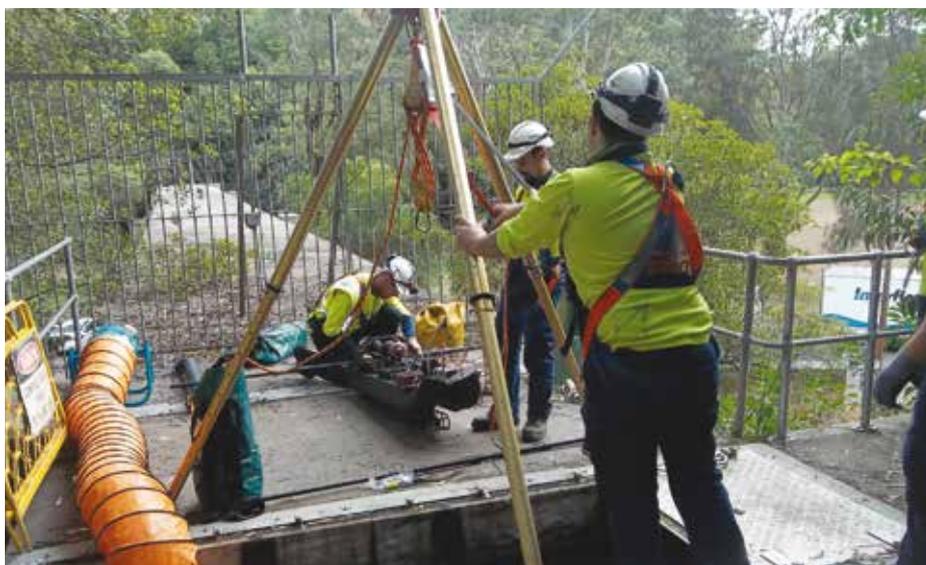
Workers using Interflow's multi-sensor inspection technology.

**INTERFLOW'S HD-PROFILER IS** a self-contained, float-mounted inspection system that provides 360 degree, full-length condition assessment for sewers with diameters from 900-4,000 mm. Its multi-sensor inspection technology supplements its CCTV recording with laser measurement above the water level and sonar signals for underwater dimensional analysis.
