Cold Work, Hot Result in Dunedin

Interflow has endured working in extremely cold conditions to successfully complete a \$1.6 million sewer rehabilitation contract for Dunedin City Council in New Zealand.

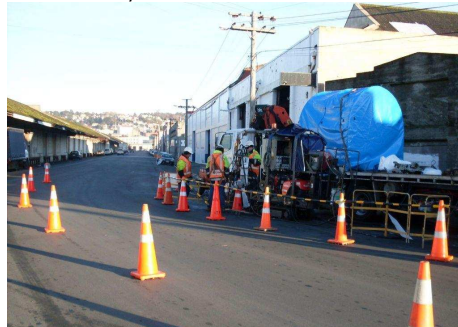
The small footprint of the Expanda installation site meant that work could be performed from access chambers located on roads whilst the road remained open to traffic

Another benefit of Expanda is that the plastic profile and the installation machine are located on the same truck which makes the site setup fast and the size of the site footprint small. Given that a large number of the access chambers on this project were located in the middle of roads, this meant the relining work could be performed with minimal disruption to the road users and the local community.

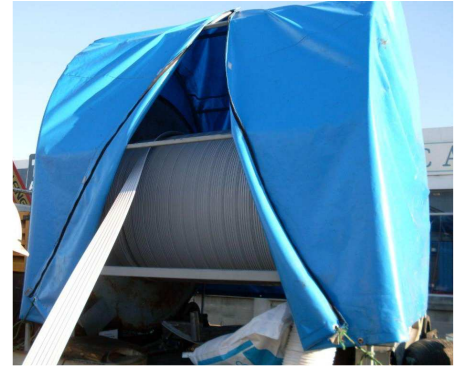
A thermal cover and frame were fabricated and placed over the spool of profile to maintain the temperature of the PVC liner above 15°C

To deal with the extremely cold conditions Interflow devised a simple yet effective method for keeping the Expanda PVC profile warm so that the installation process could be performed smoothly and without interruption.

This involved fabricating a special thermal cover and support frame which was placed over the spool of PVC profile on the truck. The cover ensured the spool of PVC profile was maintained at or above 15° in all conditions. In addition a profile heater was specially built and fitted in-line in between the profile and the winding machine so that the profile could be warmed up as it was being fed into the winding machine in the access chamber below.

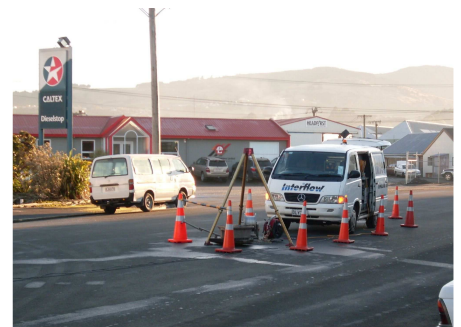
A CCTV crew performs a final survey of the pipeline after the pipe has been lined.
