Interflow delivers a “Merri” project for Yarra Valley Water

Interflow has successfully rehabilitated the Merri Creek Main (MCM) Sewer, an important component of Yarra Valley Water's (YVW) sewer network that is also located in an environmentally sensitive area.

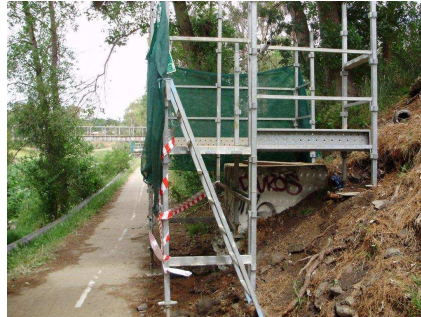
Erection of scaffolding and work platforms above raised manholes was necessary

Another challenge was that the sewer runs in close proximity to, and along, the banks of Merri Creek, as a result some of the existing manholes had originally been constructed as raised structures 2m above ground level.

To access the sewer it was necessary to construct scaffolding and work platforms around these manholes, most of which were located in difficult terrain. A benefit of Expanda is that the installation equipment is small and mobile which made installation possible.

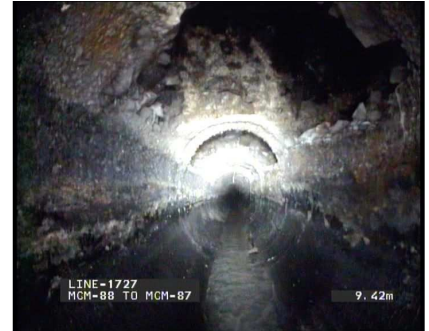
Pre lining CCTV shot inside the MCM sewer; the pipe is in poor condition and sections of the original pipe wall are missing.

The MCM was in a critically poor structural condition and in need of renewal. Rehabilitation works consisted of renewing, in total, over 2,200 metres of DN525mm and over 1,150 metres of DN600mm sewer. For this project Interflow used Expanda®, a structural close-fit, spirally wound liner developed by Sekisui Rib Loc Australia.

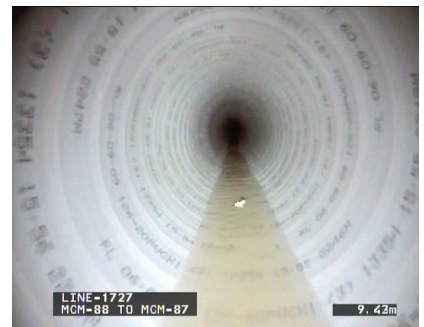
Post lining CCTV shot. Expanda can be installed in pipes with missing wall sections and the new pipe is circular in cross-section.

Despite these challenges Interflow successfully completed the sewer rehabilitation work. This consisted of sewer cleaning, relining, junction reinstatement, liner grouting in the DN600 lines and performing a final CCTV inspection.
