## Rehabilitating New Zealand's largest sewer pipe

*The project involved rehabilitating 628 metres of 1575mm and 1800mm diameter trunk sewer in Hastings as part of a sewer upgrade project undertaken by the client, Hastings District Council.*

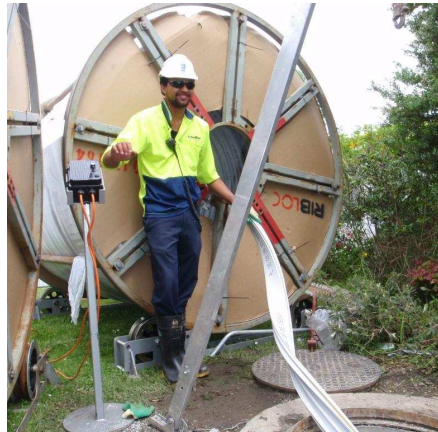
*The PVC profile was delivered to site on spools and fed into the Rotaloc winding machine in the sewer below.*

The Rotaloc liner is essentially a new pipe that is produced inside the existing pipe by machine. For this project the Rotaloc machine was lowered and assembled inside existing access chambers thereby avoiding the need for any open excavations.

The PVC profile was then fed from spools above ground into the machine below. The machine produced the new pipe by rotating and continuously wrapping and locking adjacent profile strips together. At the same time as it rotated the machine progressively advanced through the existing pipe until it reached the next access chamber. Sections of the trunk sewer between successive access chambers were renewed this way.

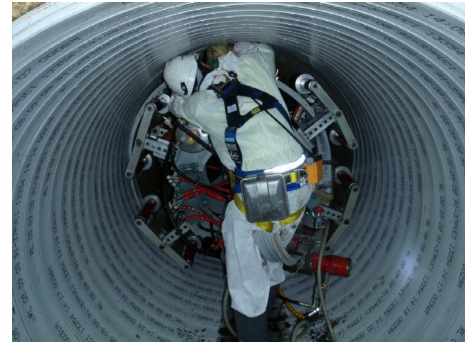
*Rotaloc restored the structural capacity of the original pipe making it safe to enter the relined sections of pipe.*

Another benefit of Rotaloc is that the liner can be installed without the need for personnel to enter and work inside the deteriorated pipe. In the case of this project this was of significant benefit because working inside the deteriorated pipe was unsafe and not permitted. After the pipe had been lined with Rotaloc, the structural capacity of the pipe was restored.

This made it safe for Interflow personnel to enter the relined sections of the pipeline.

To complete the rehabilitation work Interflow grouted the void between the outside of the Rotaloc liner and the existing pipe wall.
