**Expanda**<sup>®</sup>  
Structural Lining for  
Deteriorated Pipelines

Expanda is a full-bore structural liner that restores the integrity, reliability, and efficiency of aging sewers, storm drains and culverts with diameters from 150mm to 1200mm.

Structural Lining for Deteriorated Pipelines from the Leaders in Pipeline Renewal

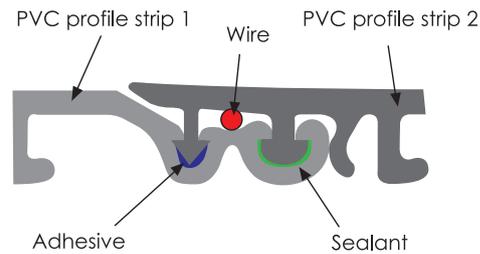
During Wind-In

The Adhesive holds the liner at constant diameter as the liner is wound into the deteriorated pipe.

During Expansion

The wire is progressively removed, severing the secondary lock. Adjacent PVC profile strips can then slide relative to each other as more profile is wound. This causes the liner to expand until it is in tight contact with the host pipe.

- 5) The diameter of the liner is then expanded so that the liner fits tightly against the inside wall of the deteriorated pipe. The expansion process is achieved by restraining the end of the liner at the terminating access chamber and pulling the cutting wire.

- 6) The cutting wire severs the secondary lock inside the profile as it is removed allowing the adjacent profile wraps to slide relative to each other.

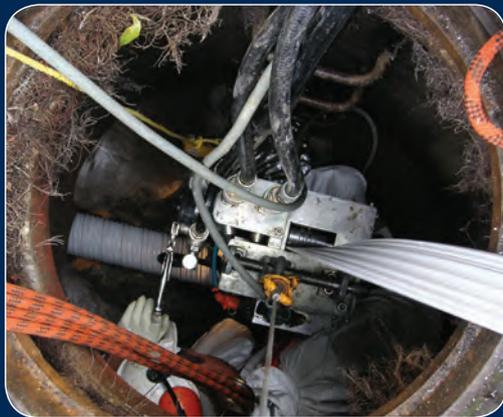
Expanda winding machine is designed to fit down existing access chamber openings.

- 1) The deteriorated pipeline is cleared of debris and obstructions, cleaned and inspected. Locations of any lateral connections are logged.
- 2) The Expanda winding machine is lowered to the base of the access chamber. The PVC profile strip is fed into the winding machine from an above ground spool.

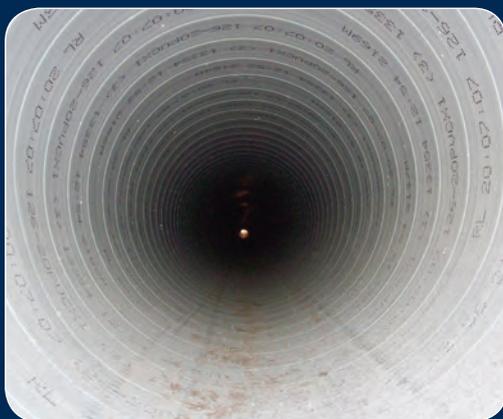
Finished product: pipe lined with Expanda.

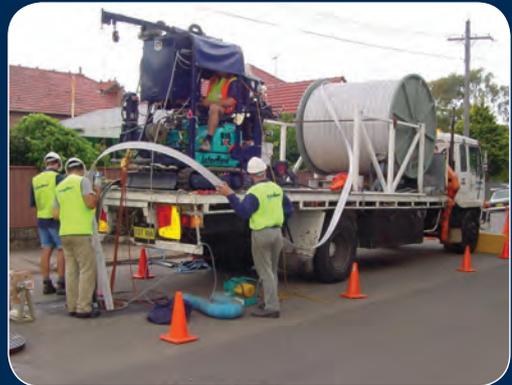
Small "footprint" of the installation set-up minimises community disruption.

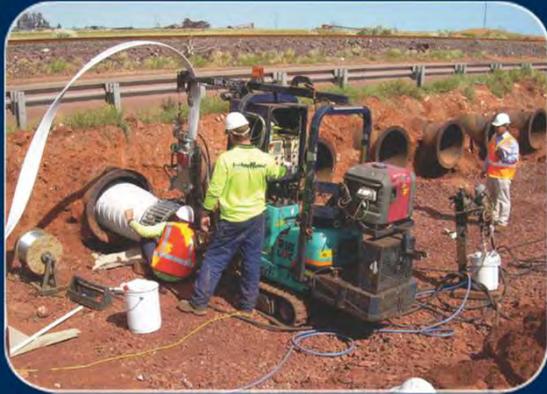
Installing Expanda in corroded rail culverts in Outback Western Australia.

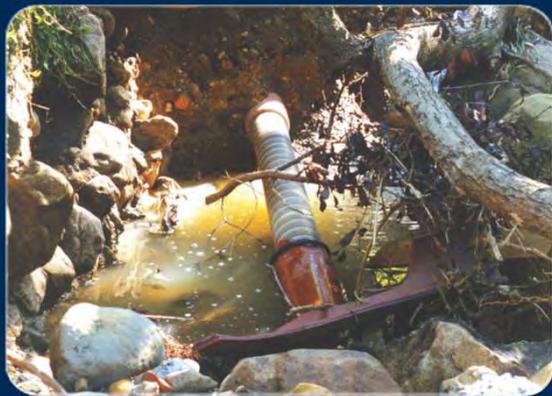
Proven strength: Floods smash the clay pipe but the Expanda liner remains intact.

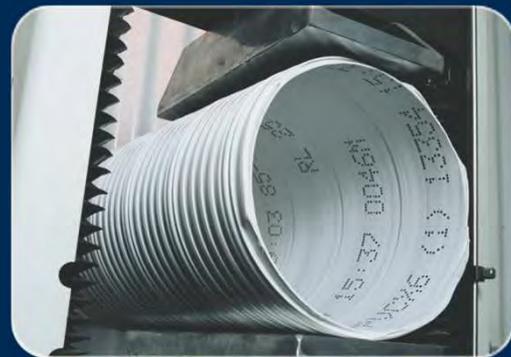
Strength testing of the Expanda liner.

- Strength tested to EN ISO 9969 Determination of Ring Stiffness
- Long-term strength tested to EN ISO 9967 Determination of Creep Ratio
- Reagent testing to ASTM D543 Resistance to Plastics Chemical Reagents
- Hydrostatic Internal Pressure Testing to confirm the sealing properties of the liner
