Interflow grabs award for rehabilitation of Western branch main sewer

Some 37 m below ground in inner-western Sydney, Interflow has installed a structural liner in 1.4 km of 2 m high, 100 year old ovoid sewer, which saw the company take out the ASTT Rehabilitation Project of the Year, presented at the Trenchless Australasia 2008 Conference and Exhibition.

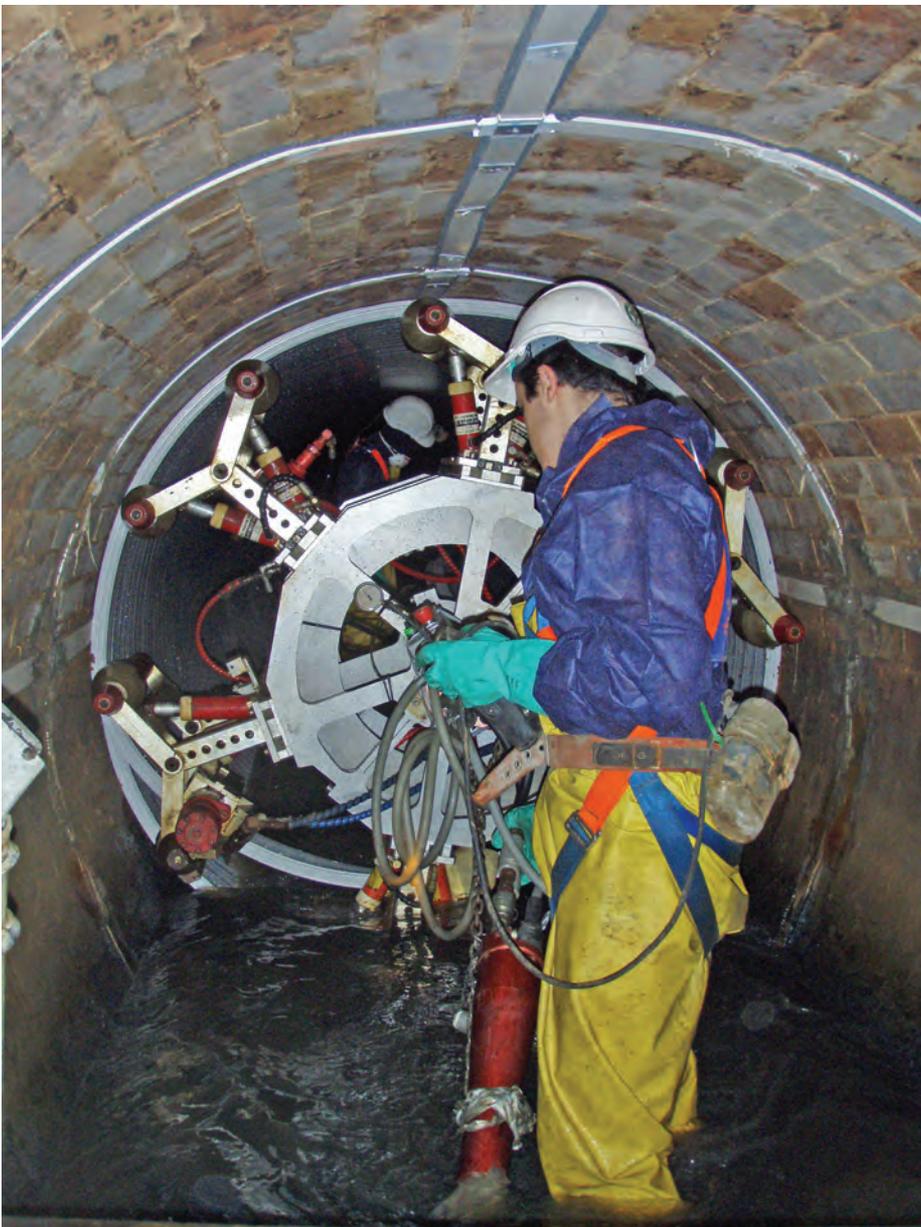
Interflow proposed to install a partial liner based on the machine wound-in-place Rotaloc system. It was considered that this offered a higher quality, lower risk solution than any of the alternatives.

Rotaloc liner has the stand-alone structural capacity to resist loads. It does not need to rely on successfully bonding to the host pipe.

The process Interflow proposed was to clean the sewer, attach the drainage strip system to the surface of the existing pipeline, place a beam along the invert of the pipeline to support the Rotaloc winding machine, mount the machine on the beam and wind the largest diameter of liner that would fill the crown of the pipeline.

Once this was done the bottom of the installed liner would be cut out and removed and the cut edges of the liner would be bolted to the wall of the existing pipeline so that the edges were the specified distance above the invert. A stainless steel angle along the cut edges of the Rotaloc liner would be installed and the liner ends sealed.
