Smooth structural liners for deformed rail culverts

by Paul Chalhoub, Products Manager, Interflow

CULVERT REHABILITATION IN THE HUNTER

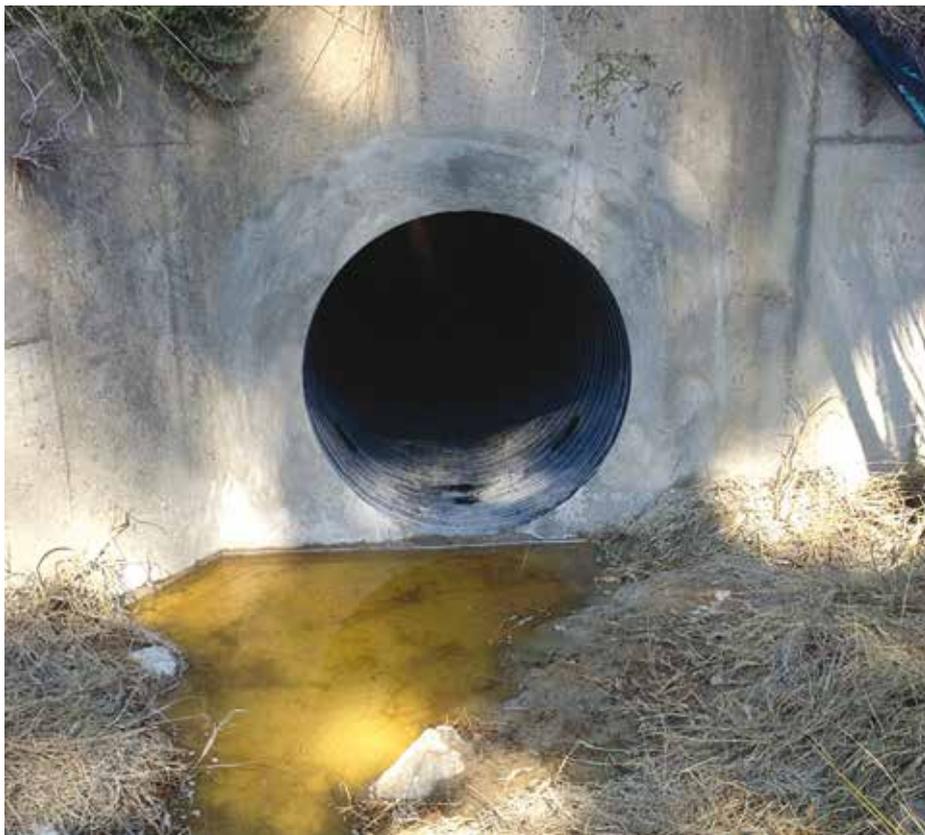
Lined and grouted culvert prior to inlet rehabilitation.

Restrained longitudinally and radially by the rails, grouting took place between host pipe and the newly installed liner.

The final stage of the works was to restore the inlet and outlet of the culverts to match the new levels of the inverts, and to accommodate the higher flow velocities that would apply because of the smooth polyethylene linings.

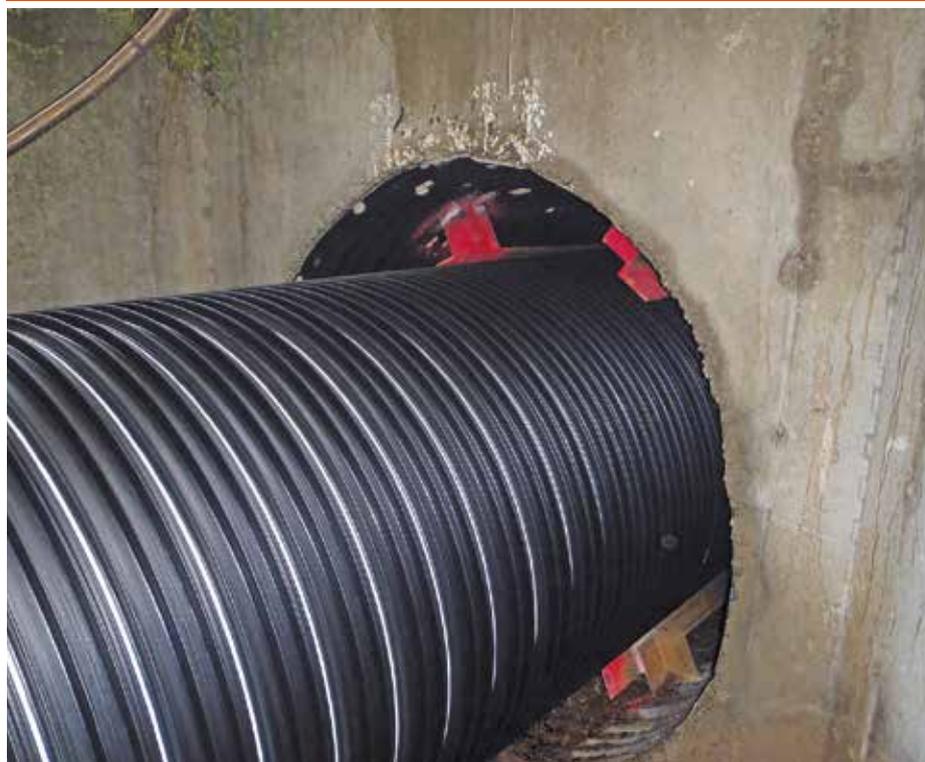
Ribline liner in place.

The rehabilitation solution selected for the repairs of these culverts was Ribline steel reinforced polyethylene spiral wound liners.

Ribline has been used for structural renewal of road and rail culverts throughout Australia for the past seven years. The liner is formed by a winding machine positioned at the headwall of the culvert. A continuous strip of ribbed polyethylene, with each rib encasing a continuous steel strip, is fed to the winding machine from a spool situated at a convenient location. The winding machine takes the polyethylene strip and winds it, continuously welding the edges together into a helix. The liner extends from the winding machine into the culvert until it reaches the headwall at the other end of the culvert.

The process installs a fixed diameter liner that must be grouted in place after installation. The winding machine is set to install a liner with the largest constant diameter that will fit into the culvert, taking into account deformations and deviations along its length.
