LIVE FLOW RELINE

Interflow completes a challenging relining project on Melbourne Water's North West Sewer.

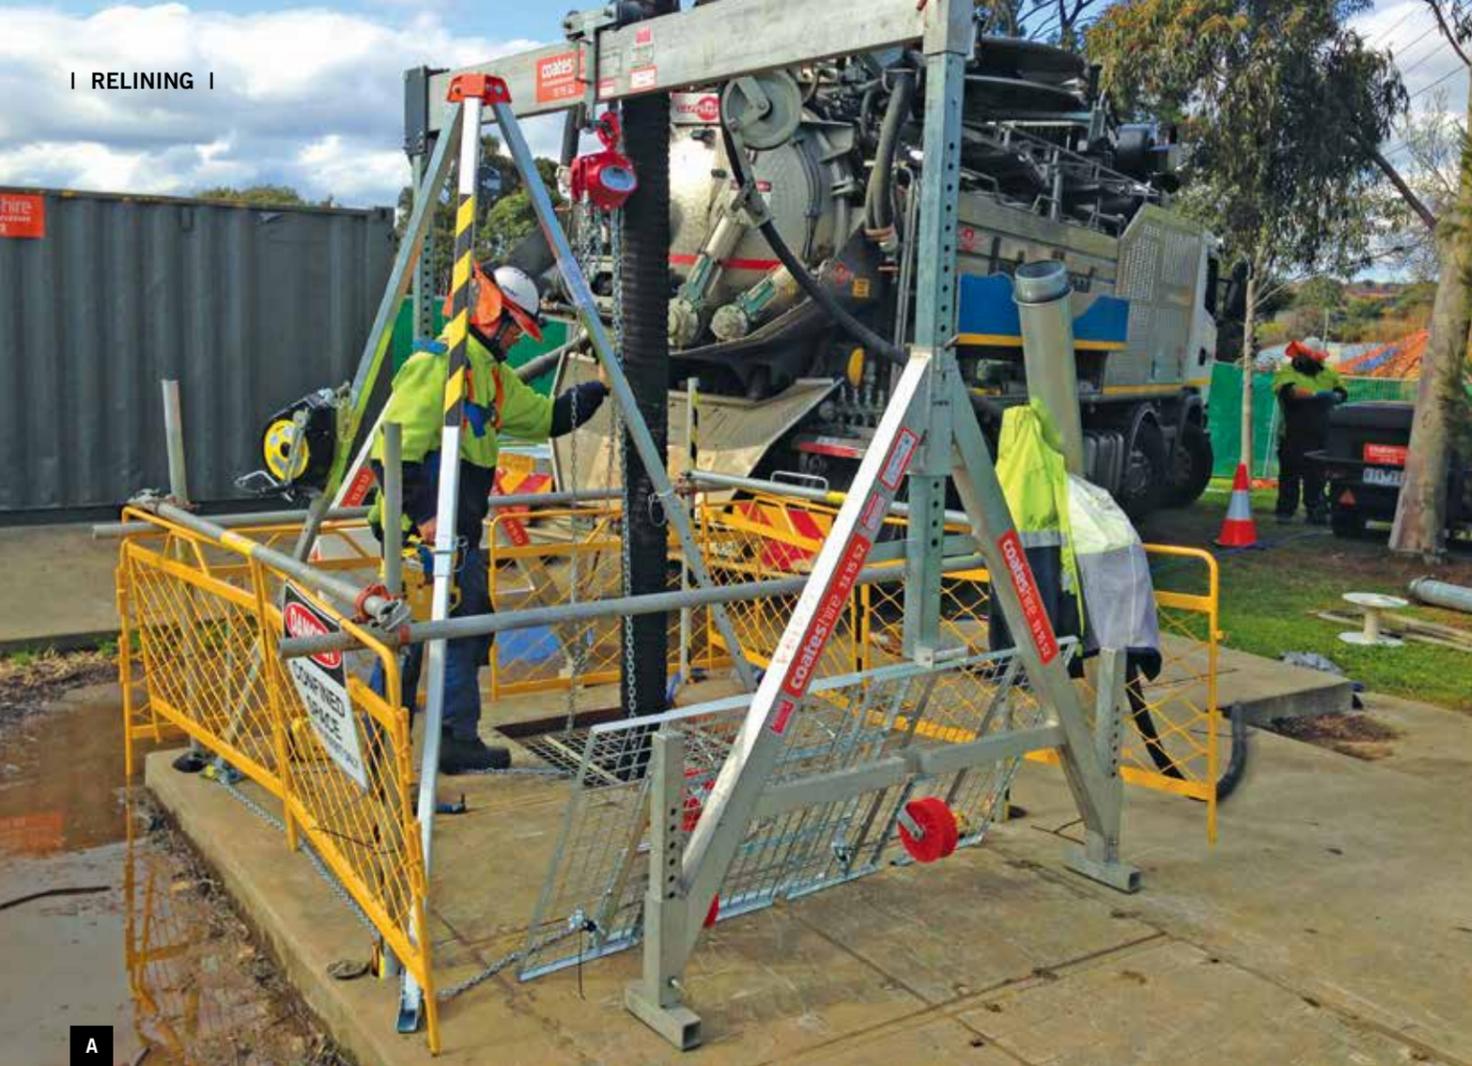
A

A: One end of the park.
B: The aboveground site set up.
