**Expanda<sup>®</sup>**  
Structural Lining for  
Deteriorated Pipelines

Expanda is a full-bore structural liner that restores the integrity, reliability, and efficiency of aging sewers, storm drains and culverts with diameters from 150mm to 1200mm.

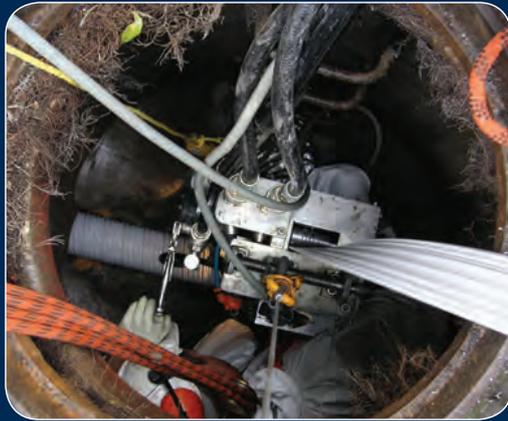
Expanda winding machine is designed to fit down existing access chamber openings.

- 1) The deteriorated pipeline is cleared of debris and obstructions, cleaned and inspected. Locations of any lateral connections are logged.
- 2) The Expanda winding machine is lowered to the base of the access chamber. The PVC profile strip is fed into the winding machine from an above ground spool.

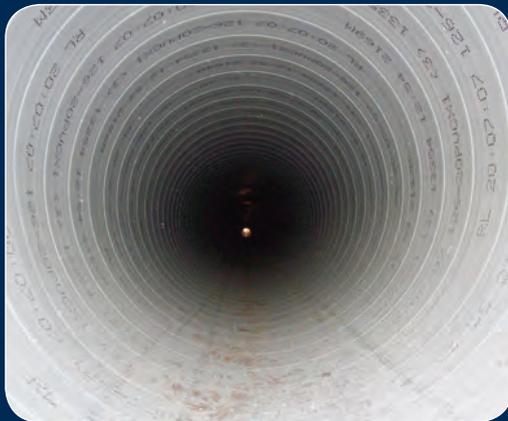
Finished product: pipe lined with Expanda.

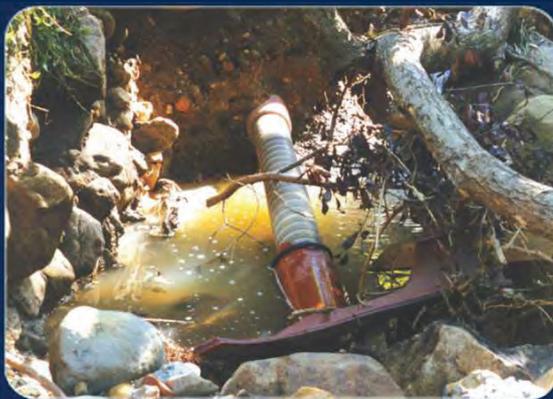
Proven strength: Floods smash the clay pipe but the Expanda liner remains intact.

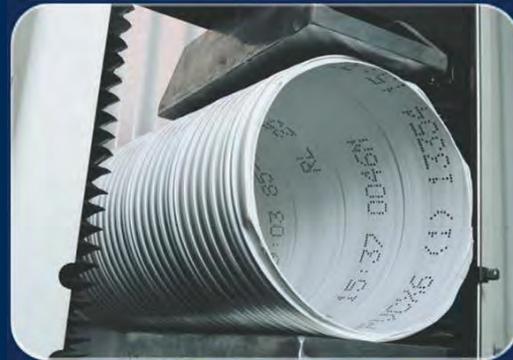
Strength testing of the Expanda liner.

- Strength tested to EN ISO 9969 Determination of Ring Stiffness
- Long-term strength tested to EN ISO 9967 Determination of Creep Ratio
- Reagent testing to ASTM D543 Resistance to Plastics Chemical Reagents
- Hydrostatic Internal Pressure Testing to confirm the sealing properties of the liner
