Sydney Water

Rehabilitation of Mosman Submain

16-WAS-SYD031-029

**SOLVING COMPLEX PROBLEMS
AND EXCEEDING COMMUNITY
EXPECTATIONS IN MOSMAN**

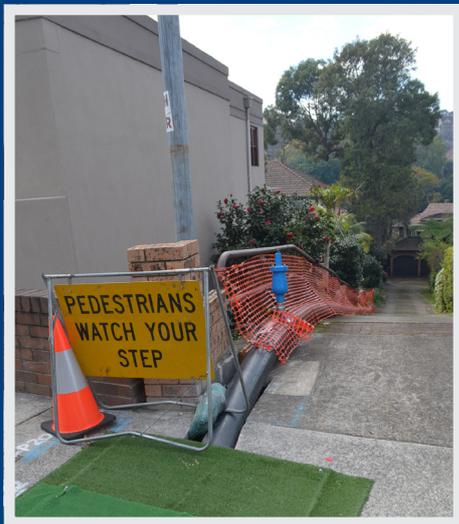
Bypass pipework located adjacent to fences providing safe and unrestricted access to properties and the local roadway.

The welded polyethylene bypass line was constructed in situ and positioned to run to one side of driveways and an easement. Where the line needed to cross a backyard it was placed as far away from the house as possible, so that access and residents' use of their properties was not unduly affected.

Temporary pipework along roadways was laid in trenches so there were no forced road crossings and no disruption to local traffic. Other measures included installing a non-slip walkway to maintain access to a local walking track.
