Interflow[®]

Anstruther Street Bypass
Pumping

Anstruther Street, Echuca VIC

BYPASS PUMPING TO ALLOW INFRASTRUCTURE UPGRADES

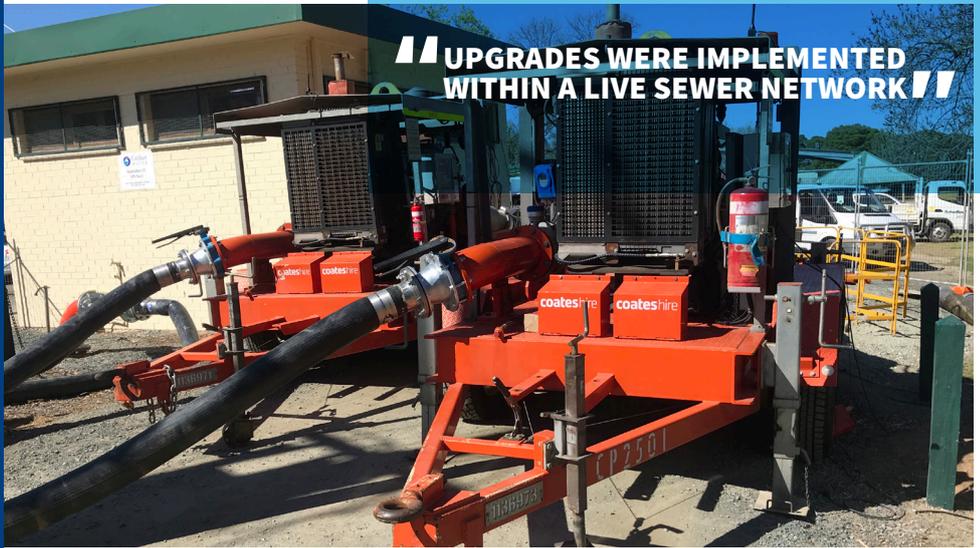
UPGRADES WERE IMPLEMENTED WITHIN A LIVE SEWER NETWORK

Interflow was approached by the client to provide support to their mechanical and electrical subcontractor in the form of setting up a bypass pump arrangement. This allowed the upgrades to be implemented within a live sewer network in a period of one week.

In order to create the bypass, a vacuum truck was used to pump down the network sewer. This allowed the crew to insert pneumatic bungs within the connecting pipes of an upstream manhole and the pump station wet well (at 12m deep).

Once the bungs were installed, the vac truck sucked out the manhole periodically, whilst the crew set up the dual bypass pumps and temporary transfer pipework. Suction pipes were inserted into the manhole and delivery pipework connected to an above ground flanged assembly (downstream of the Pump Station and isolated via an inline gate valve), subsequently bypassing the work zone.

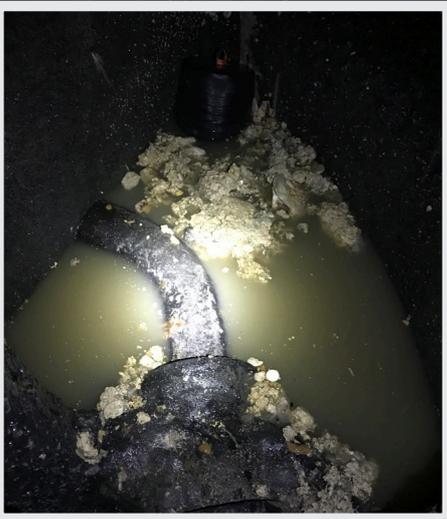
Pump Station wet well chamber

Double isolation was provided by inserting bungs from both ends of the pipe between the manhole and the Pump Station wet well. When the pumps were removed, blank flanges were then bolted onto the flanged pipework inside the wet well which mechanically provided isolation in addition to the two bungs.
