## TRENCHLESS REHABILITATION OF THE UPPER HOBSONS BAY MAIN SEWER

Matthew Pratt<sup>1</sup> and John Monro<sup>2</sup>

Rehabilitation of the 110-year-old Upper Hobsons Bay sewer in Melbourne saw the completion of one of the world's largest UV-cured fibreglass CIPP lining projects.

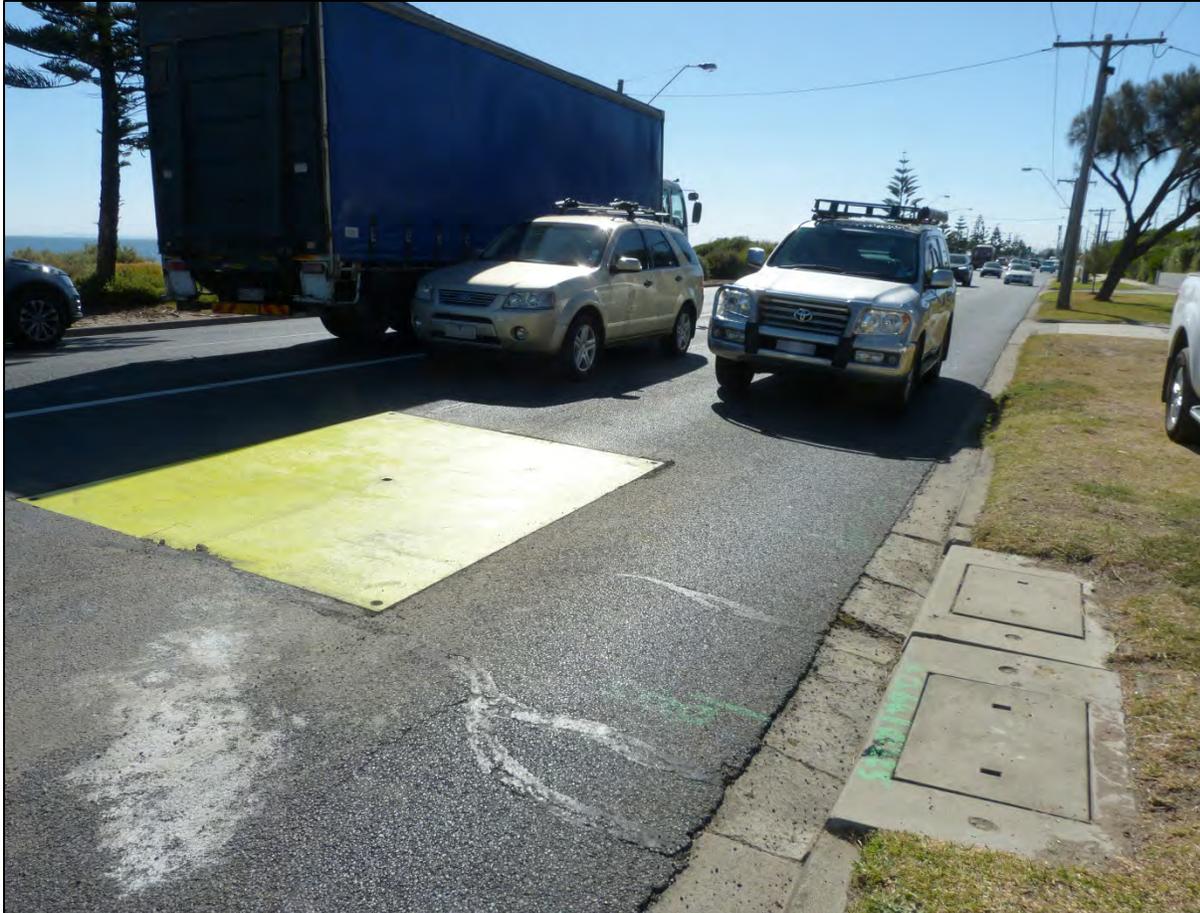
Figure 2: Road plates were recessed flush with the road surface and coated with a highly visible, non-slip finish. A new standard praised by Bicycle Network.

Special road plates were developed to enable the quick set up and pack-down of work sites. The road plates were designed with subcontractor JHL to ensure practicalities and experience were utilised. The road plates were specially designed to be fully recessed into the roadway, resting on isolation rubber to minimise noise (due to rocking plates) and finished in a high-visibility, non-slip coating to provide a smooth transition from the road surface onto the road plate. The recessed roadplates were a finalist in the 2018 Work Safe Awards and Bicycle Network prased the initiative as a practice which should be embraced across the industry.

No complaints or property damage claims were received by the project team during the 3 ½ month duration that road plates were installed.

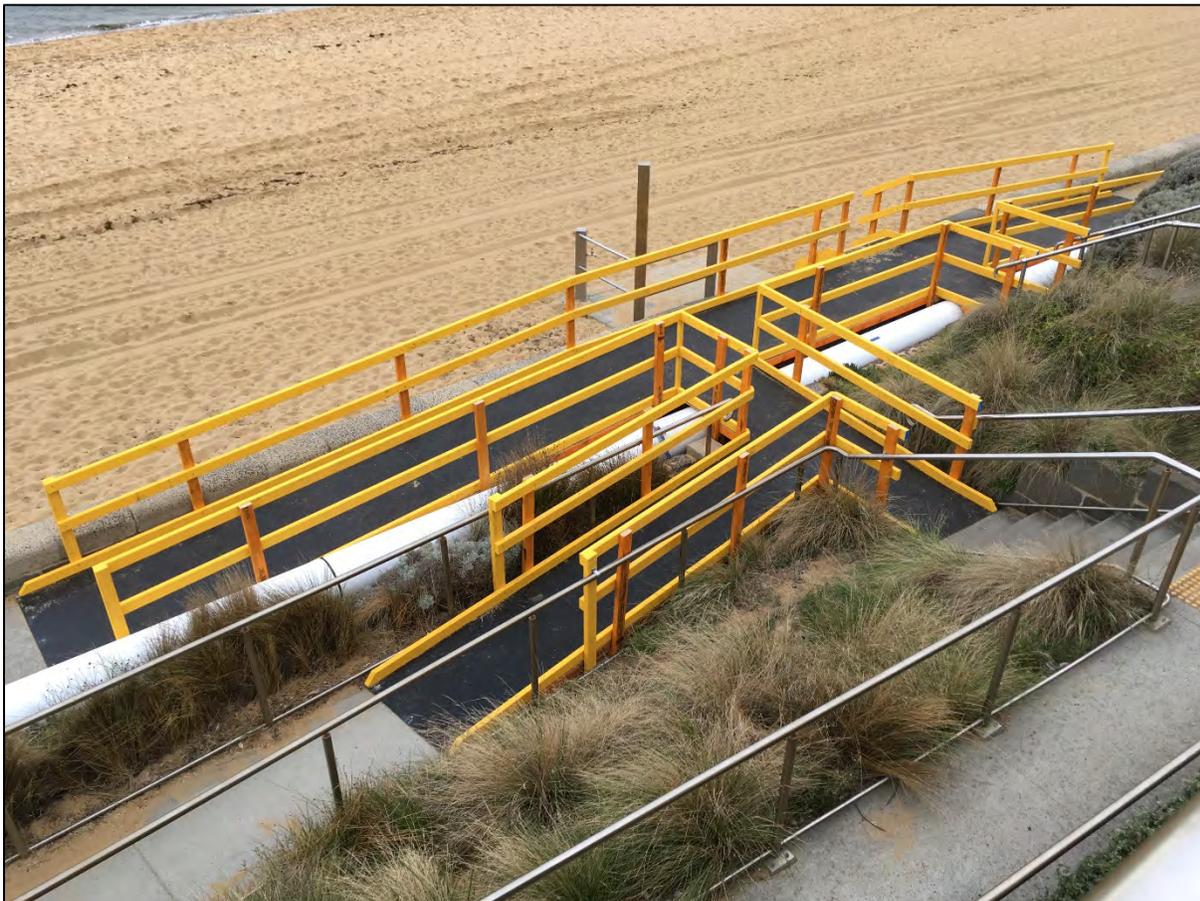
Figure 3: Modular ramp built on foreshore shared user path for cyclists and pedestrian accessibility.

At places where the bypass pipeline crossed shared user paths, the project engaged a specialist contractor to produce fully accessible modular ramps so that cyclists were not required to dismount. The ramps can be installed and removed quickly to minimise impact to pathways and are easily adaptable for changes to access. The ramps have a solid ply base with non-slip surface to cater for narrow bicycle wheels and hand rails painted in bright yellow for maximum visibility for both cyclists and pedestrians. All 17 constructed ramps complied with the Disability Discrimination Act and consisted of a continuous deck with chamfered transitions, eliminating gaps which are often hazardous for road cyclists. When needed, area lights were installed to provide additional visibility in the changed conditions. The ramps were designed and constructed with a modular focus, not only facilitating reuse of the ramp components between bypass stages but also allowing the ramps to be utilised on future projects, minimising waste.

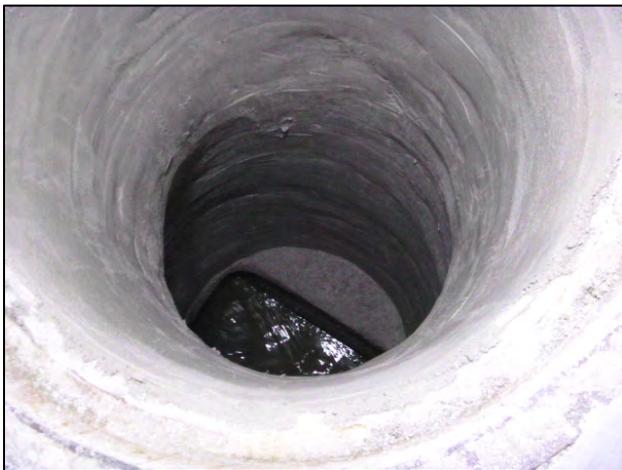
*Figure 4: Manhole restored and coated with calcium aluminate cement*

Cleaning of the deteriorated concrete surface is essential if any coating system is to be effective in the long term. Ultra high pressure jetting was used to clean all acid attacked concrete and tests were conducted to ensure the surface was sufficiently cleaned and prepared for the calcium aluminate cement coating. The pressure varied depending on the circumstance.

The calcium aluminate cement was applied by spraying. For the deep manhole – up to 11 metre deep – temporary platforms were initially assembled, but a “bosuns chair” system was later adopted, which made the process significantly faster..

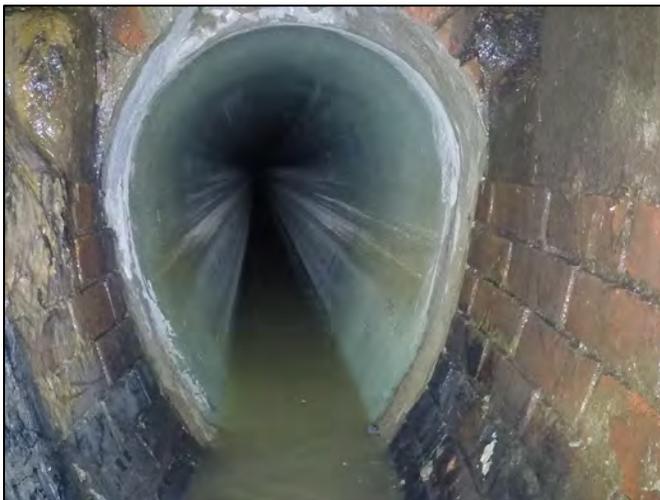
Figure 5: Installed UV CIPP Fibreglass liner, with end sealed

- Stage 1: CCTV inspection to confirm the existing ovoid is in suitable condition for relining.
- Stage 2: Pulling through the “glide foil” which sits in the invert to the sewer. Glide foil is needed to ensure that a smooth, low friction invert is provided for the liner
- Stage 3: Winch the CIPP fibreglass liner into the sewer
- Stage 4: Internally seal the ends of the liner, then inflate so the liner takes the shape of the existing ovoid

- Stage 5: Cure the liner. The UV light train is winched up inside the liner in a “dummy run” to confirm it runs smoothly. The UV lights are then illuminated and the “train” winched back along inside the liner. Speed and wattage are monitored and computer controlled to ensure the liner attains the correct curing temperature for the correct length of time, considering the wall thickness. This stage can take from 4 to 10 hours.
- Stage 6: Cool down the liner
- Stage 7: Disassemble the lining mechanism, then seal the liner ends with Hypeform sealant.
- Stage 8: Reinststate lateral junctions to the sewer manually, by person-entry
