# TRENCHLESS

ISSUE 62 | MARCH 2020

# First in line for trenchless rehabilitation solution

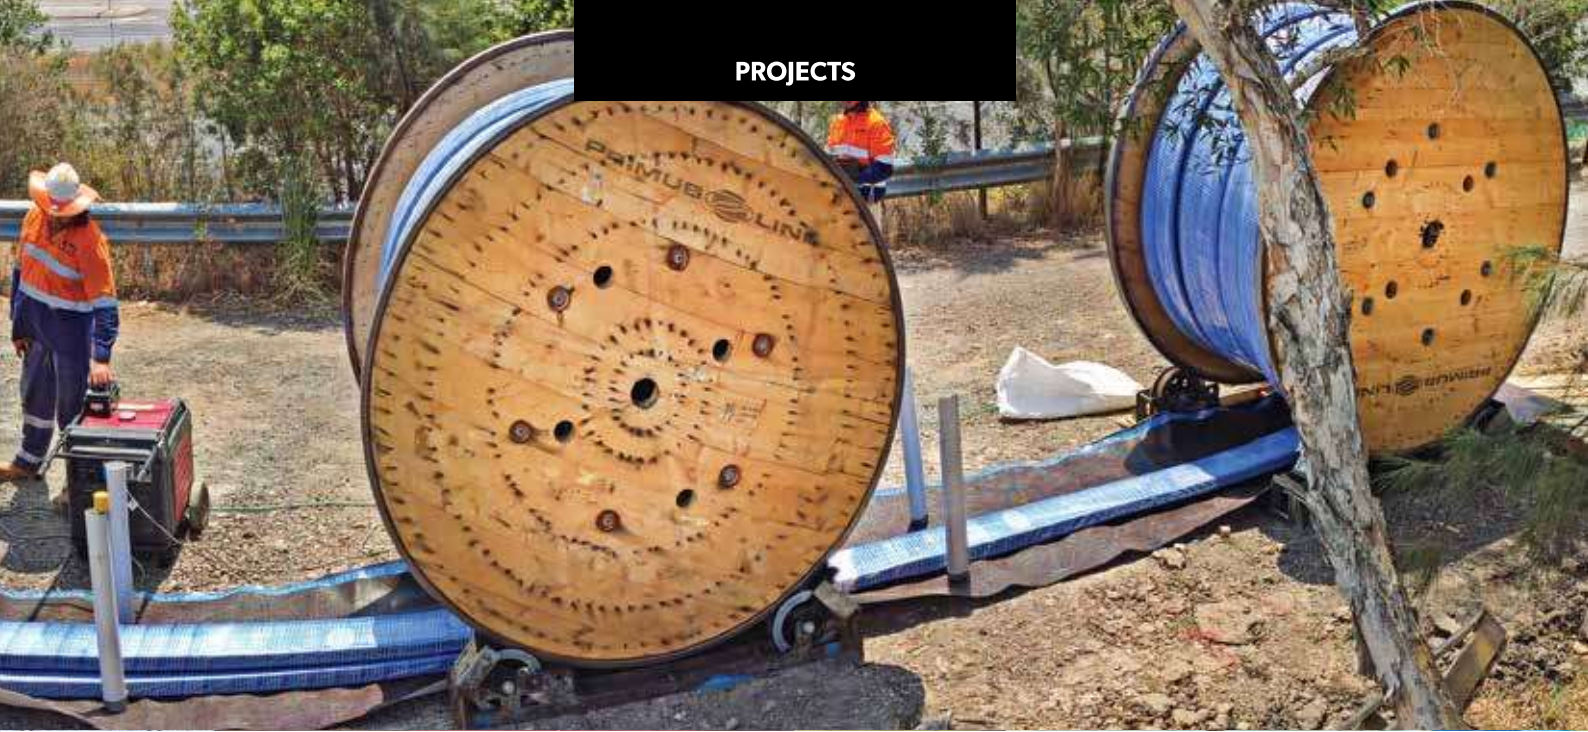
**Opposite:**  
The three spools reels aligned onsite.

To reach the construction site, the Primus Liner was transported on three reels and then placed

sequentially behind the start pit in line with the run of the pipeline. Each liner was marked with a different colour of tape to ensure that the hoses were at the correct positions of both pipe ends after insertion.

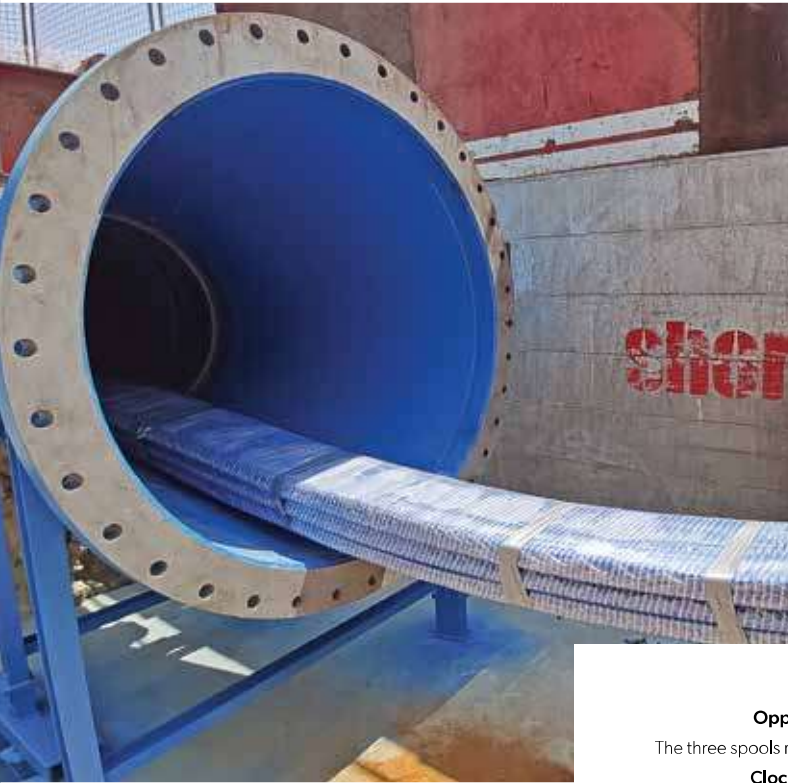
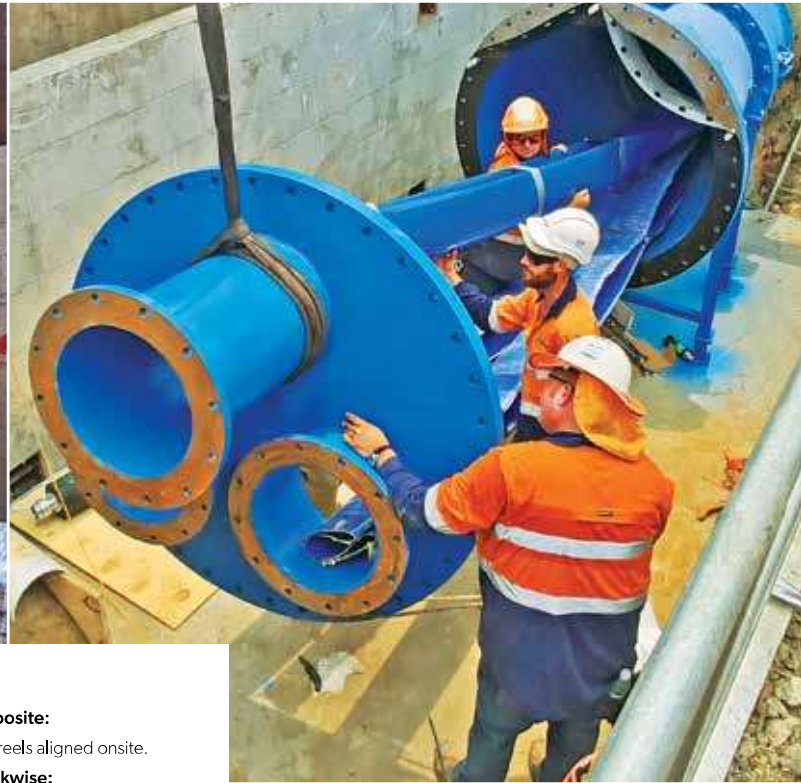
**Clockwise:**  
During installation, Interflow threaded the Primus Liner through the manifold prior to expansion.

During insertion, the liners were combined and stacked then fixed with tape for identification and to keep their shape. After insertion by a pulling winch, Interflow threaded the liners through the manifold and brought them into shape one-by-one with compressed air.
