## STRUCTURAL RENEWAL OF DETERIORATED UNDER ROAD CULVERTS

John Monro, Technical Support Manager

### ABSTRACT

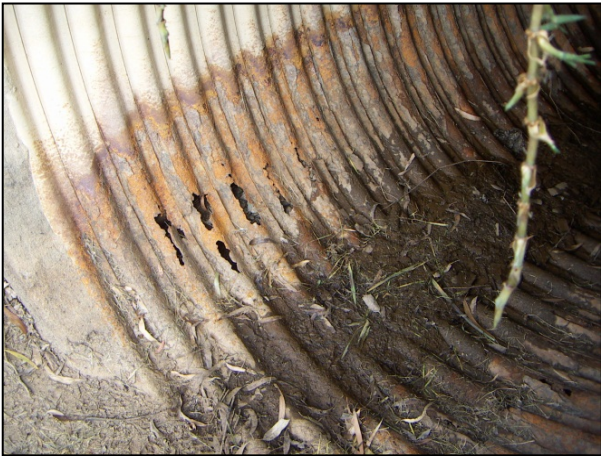
Fig 1: Perforations in the rusted invert of a corrugated metal culvert

Abrasion and corrosion are issues that can cause rapid deterioration in corrugated steel and aluminium culverts. FRC culverts also seem to be particularly vulnerable.

Abrasion of the pipe wall occurs through the action of materials carried in flow impacting on the pipe wall.

Debris carried in high flow storm events, such as tree branches, boulders or any other substantial debris can impact on the pipe walls causing serious damage. The situation can be made worse if the flow is acidic. The problem is greater on the upstream side of the corrugations.

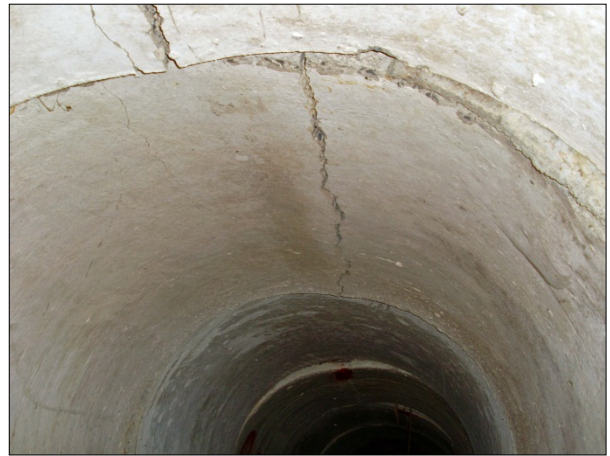
Fig 2: Cracks in the top of a reinforced concrete culvert

Concrete culverts are not immune from deterioration. Their life can also be shortened by corrosion and abrasion, but being rigid, they are more susceptible to cracking caused by repetitive loading or ground movement.

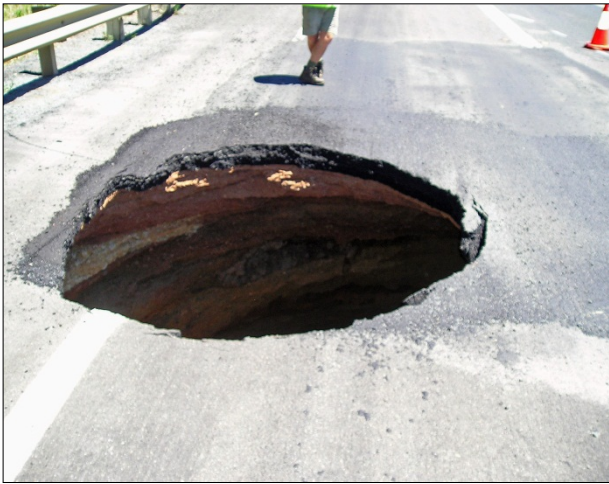
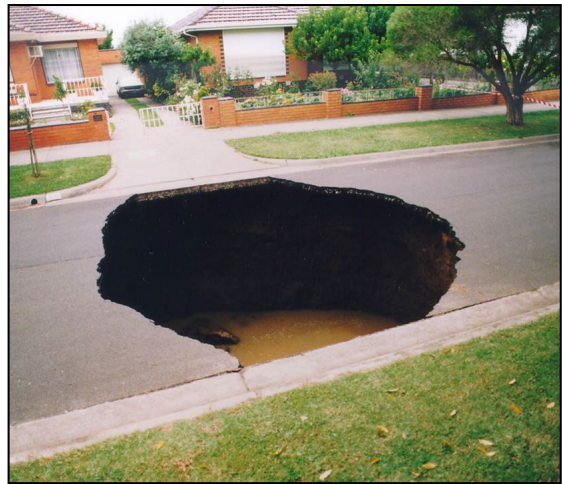
Figures 3 and 4: Road collapses caused by embedment being washed into a deteriorated or defective culvert or pipeline, leading to the formation of voids beneath the surface.

Joint dislocation can occur as a result of errors in the installation process, including improper alignment, or improperly installed bedding or backfill. Settlement or other forms of pipe movement (ground movement or landslides) can produce differential movement of pipes, leading to openings in the joints of the pipe.

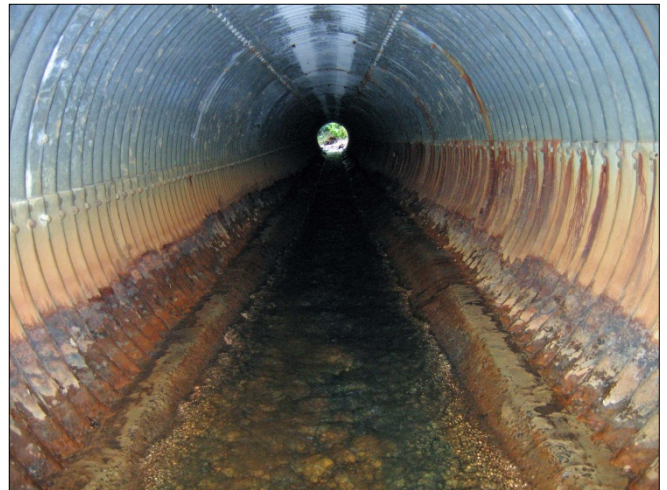
*Figure 5: Concreting the invert of a culvert can extend its life, but ultimately moves corrosion and abrasion problems further up the wall.*

For corrugated metal culverts, the most common type of partial repair is to line the invert with concrete. While this can increase the resistance of the invert to corrosion and abrasion, it merely moves the problem further up the wall of the culvert.

In these instances, partial repair may be a less cost-effective option in the long term than the renewal option. The other important consideration is that the concrete layer in the invert can hamper the works when it is decided to affect the permanent renewal option. Often the original bore size of the culvert is needed so as to avoid hydraulic loss, and when this is required the concrete may need to be removed prior to carrying out permanent renewal works. Removal of the concrete from a prior partial repair job, will increase the cost of a permanent renewal option.

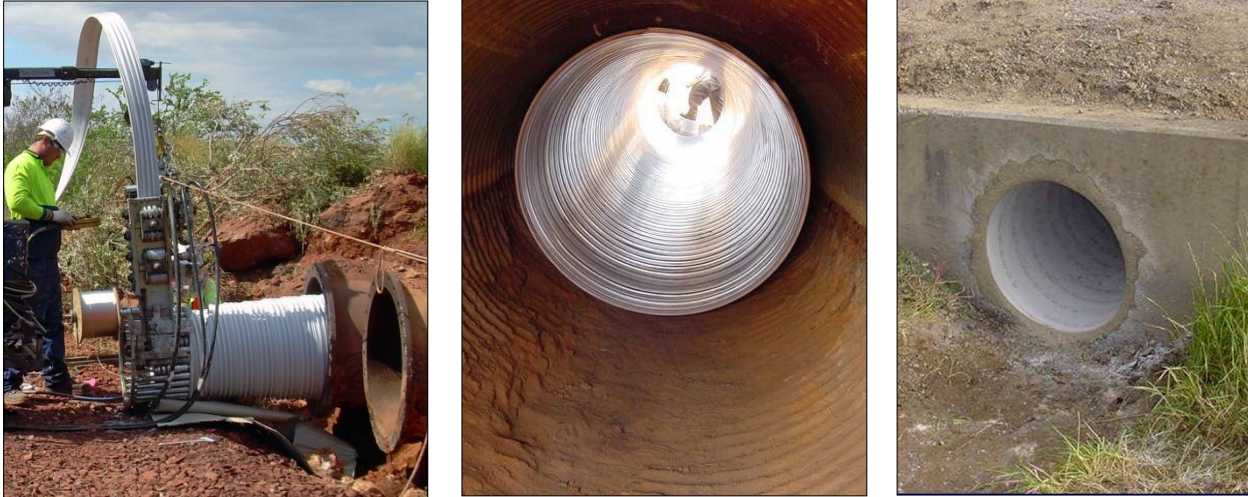
Figure 6: Installing Expanda Pipe in under-road and rail culverts

A continuous strip of UPVC is fed to a winding machine placed at the base of a manhole or adjacent to the headwalls of a culvert. The winding machine takes the plastic strip and winds it into a continuous helix, locking the edges together. The liner "corkscrews" up inside the deteriorated culvert until it reaches the far end. Obviously the liner must be initially installed at a smaller diameter than the conduit it is lining.

A unique feature of Expanda Pipe is that a patented mechanical process is used to expand the liner tightly against the host conduit wall after initial installation. This means there is minimal loss of internal diameter.

The plastic strip is smooth on the inside with continuous stiffening ribs down the other side. This gives the liner a smooth inner bore, maximum structural stiffness and minimum weight. Different weights and heights of plastic strip are available to allow a liner to be provided that meets design requirements.

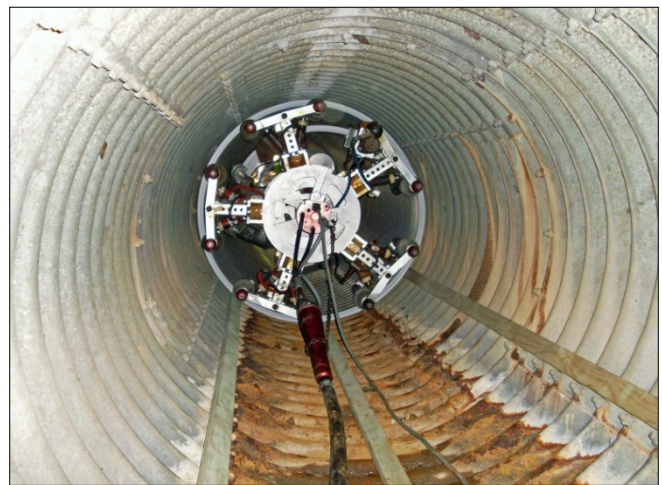
Figure 7: Rotaloc liner being installed in a corrugated metal culvert

Rotaloc is also a UPVC liner but differs from Expanda Pipe in that the winding machine travels up the deteriorated conduit, rotating and winding the liner, locking the edges of the UPVC strip together. The winding machine can alter diameter as it moves, so providing a liner as close as possible to the conduit wall, even if the diameter changes along the conduit length. Loss of internal diameter is minimised.

Rotaloc uses heavier, thicker plastic strip than Expanda Pipe, so can meet the structural stiffness requirements of larger diameter liners. It is typically used for lining pipelines and culverts with any diameter from 900mm to 1,500mm.

Cementitious grout is injected behind the liner after installation to fill any gaps between the liner and host culvert, as well as voids in the host pipe. By providing additional support to the liner, cementitious grout increases the liner's load carrying capacity allowing it to be applied to badly deteriorated culverts under high embankments.

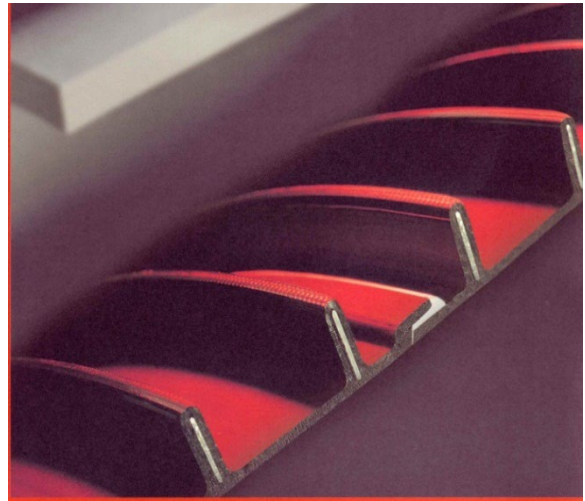
Figure 8: Cross section of Ribline polyethylene profile showing the steel reinforcement in each rib and the weld joining successive helically wound strips

Ribline is a high-density polyethylene liner reinforced with steel. It is used for lining culverts with diameters up to and exceeding 3,000mm. The liner is smooth on the inside with ribs on the outside. Each rib encases a continuous strip of steel.

The liner is supplied as a continuous strip of steel reinforced polyethylene profile that is helically wound-in-place in the host culvert by a machine located at the headwall.

The edges of the profile strip are joined by extrusion welding, with the welding head located inside the winding machine. Ribline is thus a strong, joint-free liner.

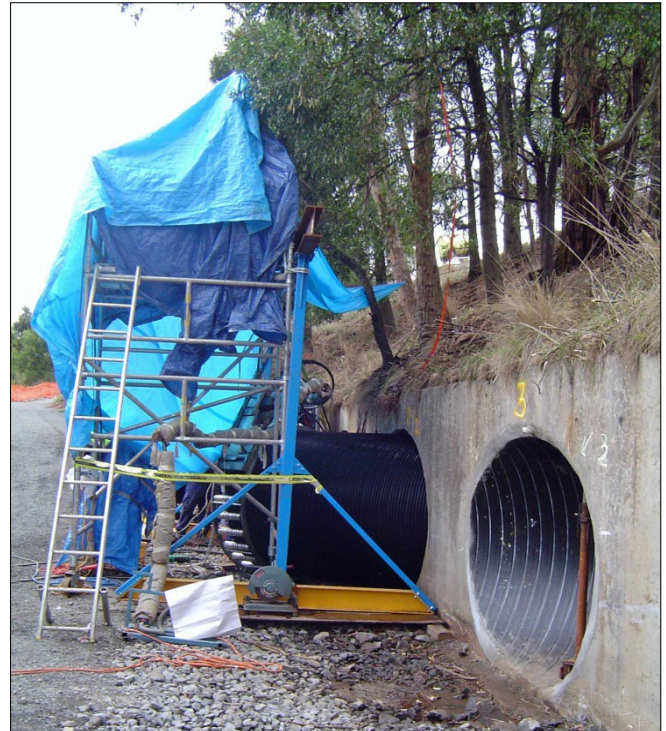
Figure 9: Installing a Ribline liner in an 1830mm diameter culvert. Note the culvert in the foreground has been completed, including grouting and epoxy end sealing.

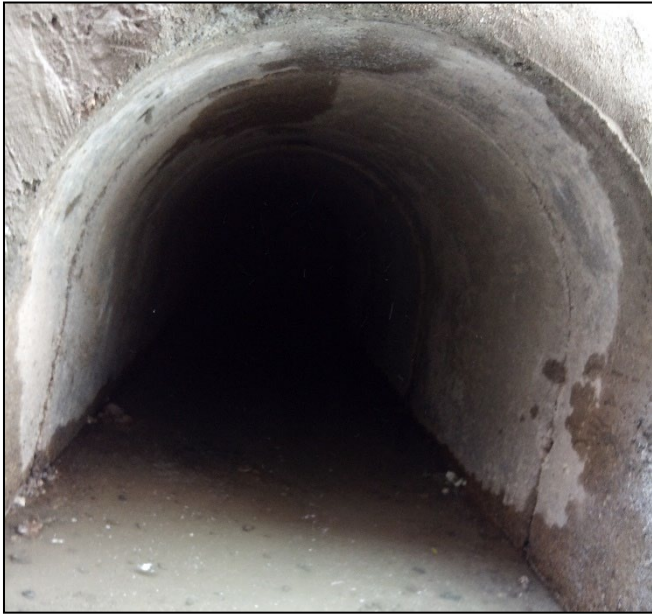
Figure 10: Non-circular culvert subject to deterioration and heavy siltation

*Expanda Pipe:* A recent unconventional New Zealand example was a project in Stevenage, Hamilton. This required lining of a non-circular culvert with vertical sides, a flat invert and an arched crown. A circular liner was installed, expanded to the maximum circular diameter that would fit. The void around the outside of the liner was filled with cementitious grout. As well as providing structural renewal, with the grouted liner designed to take all loads, lining improved the flow characteristics as the smooth circular invert as it minimised the possibility of future silt build up.

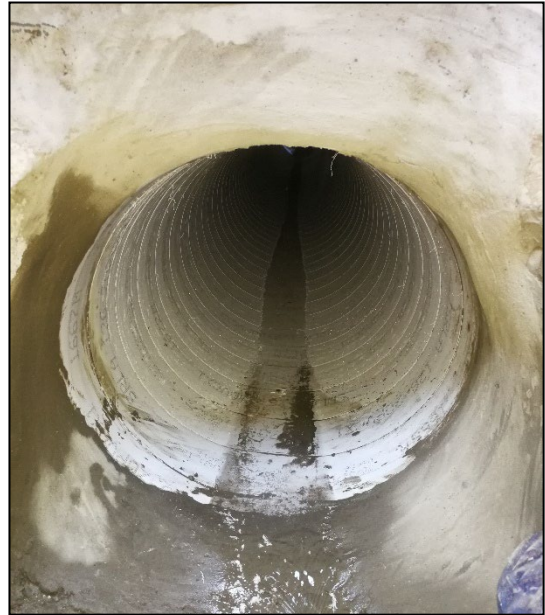
Figure 11: Expanda Pipe liner installed restores structural capacity. Curved invert reduces siltation
